# Inspection Report

**Property Address:**  
1234 79th Dr. N.E.  
Seattle WA 98223

**Sound Choice Home Inspections**

<b>Date:</b> 3/12/2017	<b>Time:</b> 02:30 PM	<b>Report ID:</b> 123417 79
<b>Property:</b> 1234 79th Dr. N.E. Seattle WA 98223	<b>Customer:</b> Joe Sknovich	<b>Real Estate Professional:</b>

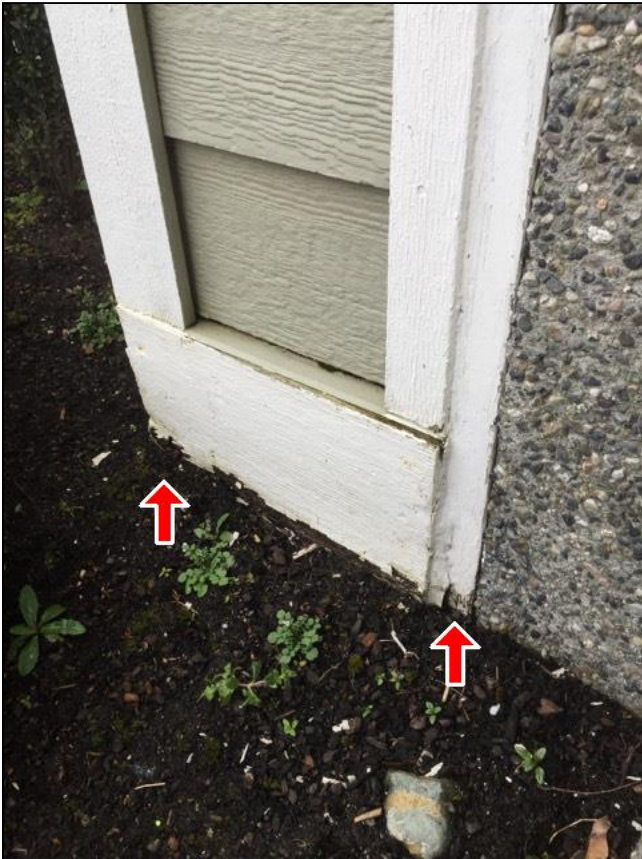
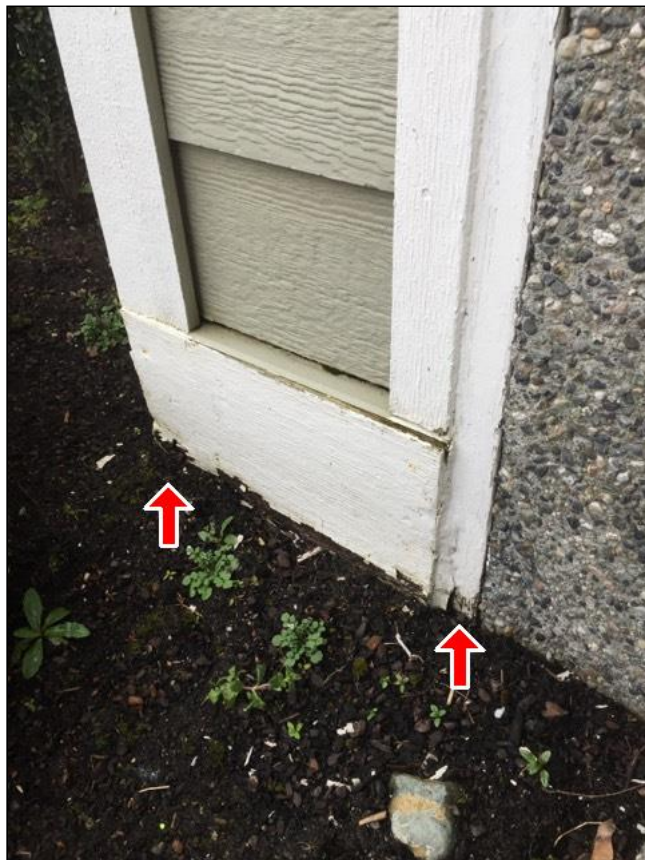
1.0 Item 1(Picture) Front house trim damage

Item 1(Picture) Front house trim damage: The trim at the front (east) side of the house had trim board damage where the wood was in contact with the soil. Recommend replacing damaged trim boards and maintaining a 6-8 inch space between wood and soil.

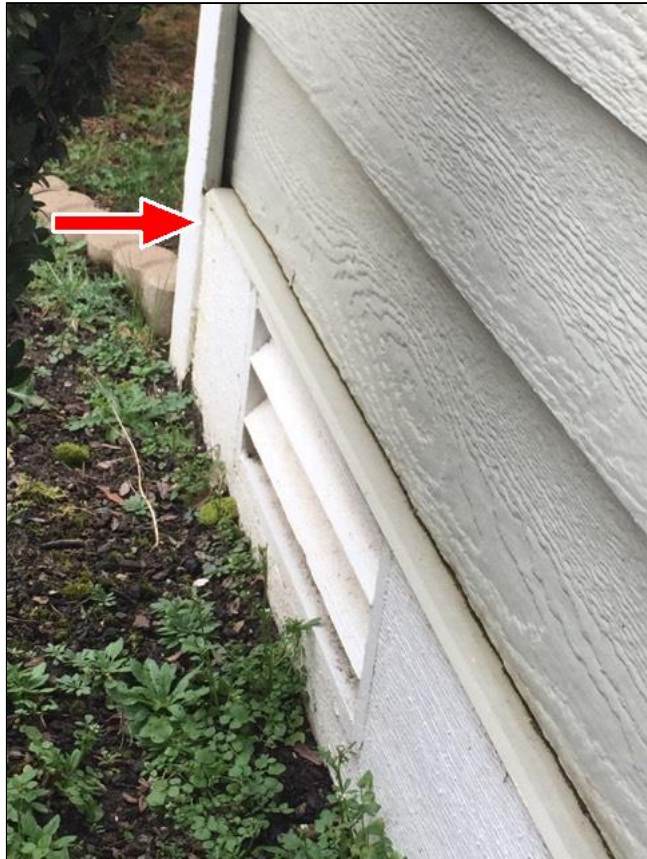
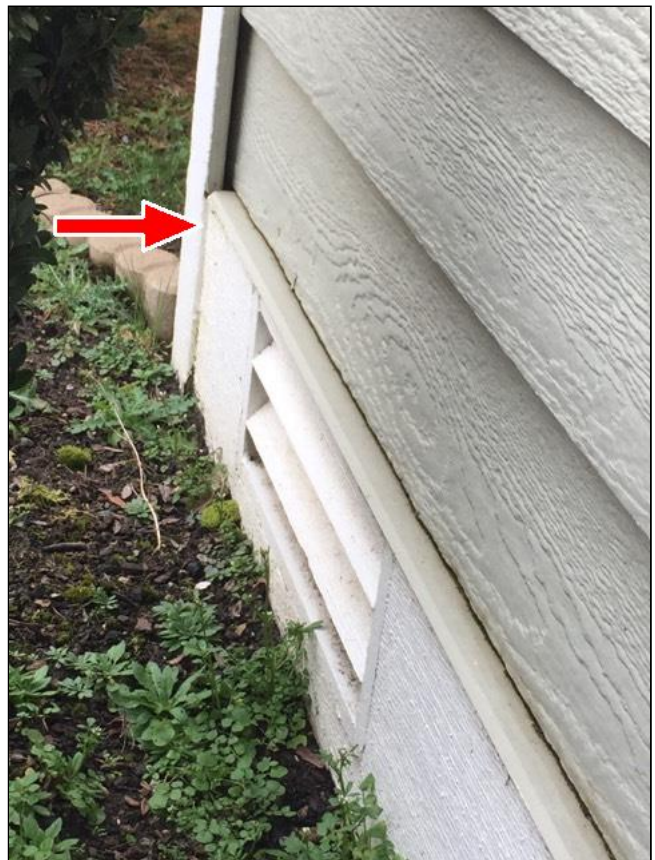
1.0 Item 2(Picture) Flashing at the SE corner

Item 2(Picture) Flashing at the SE corner: Flashing at the SE corner trim boards did not adequately cover the top of the trim boards. Recommend repair and replace ant damaged boards.

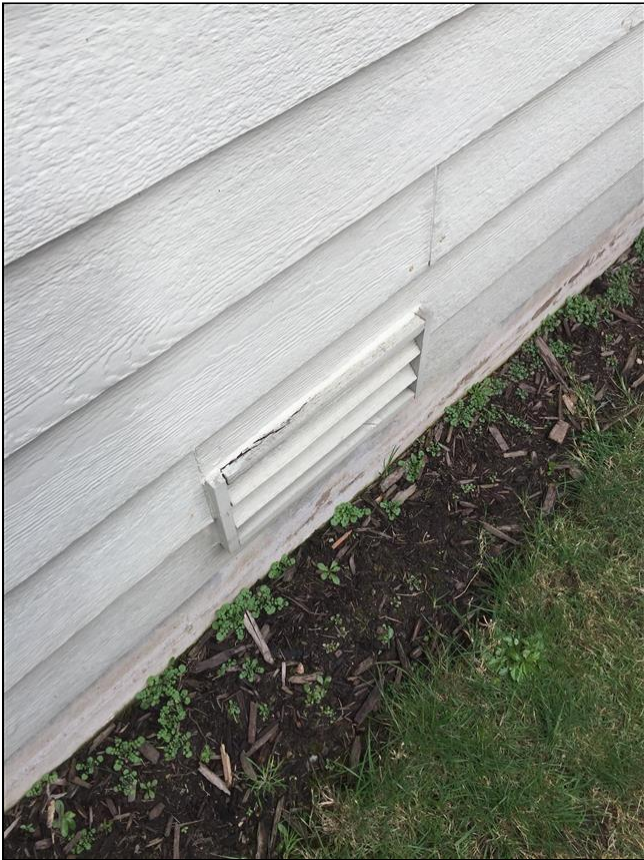
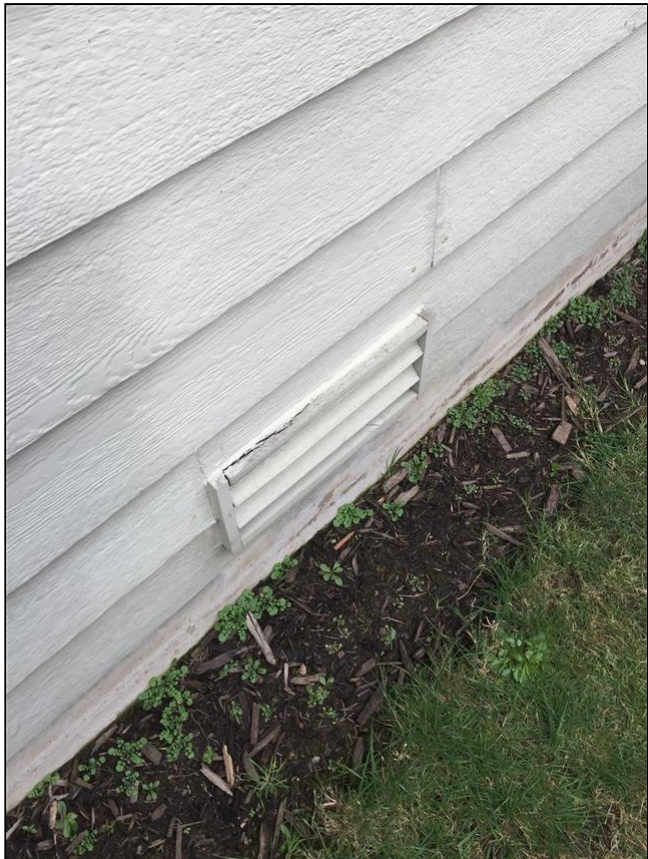
1.0 Item 9(Picture) Vent trim board damage

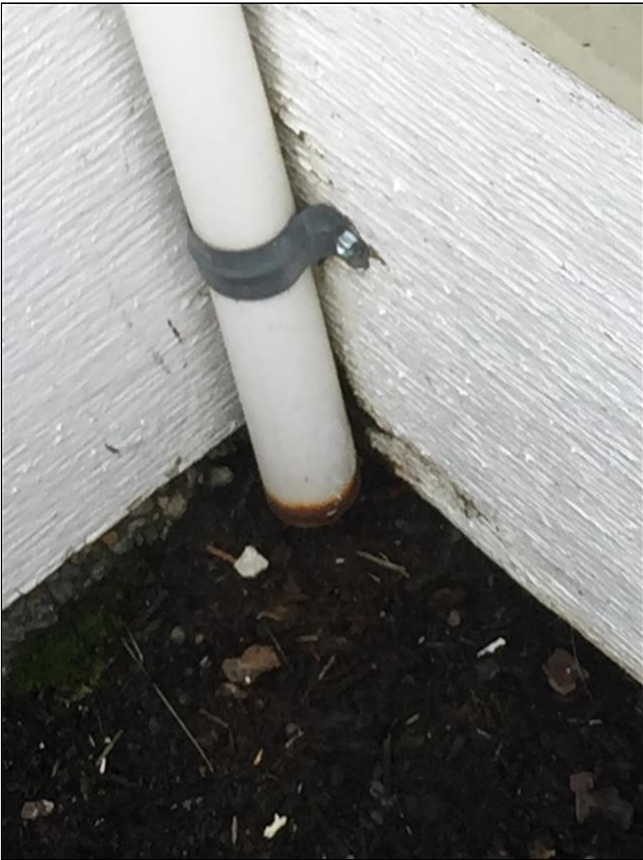
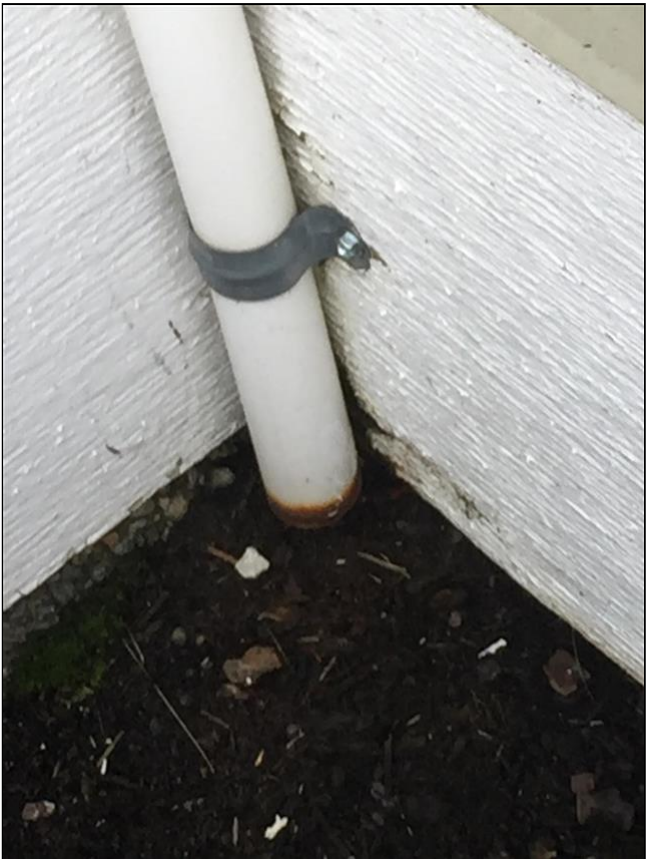
Item 10(Picture) Trim boards behind the TPR valve pipe: Trim boards behind the TPR valve pipe were rotted. Recommend replacing.

1.0 Item 10(Picture) Trim boards behind the TPR valve pipe

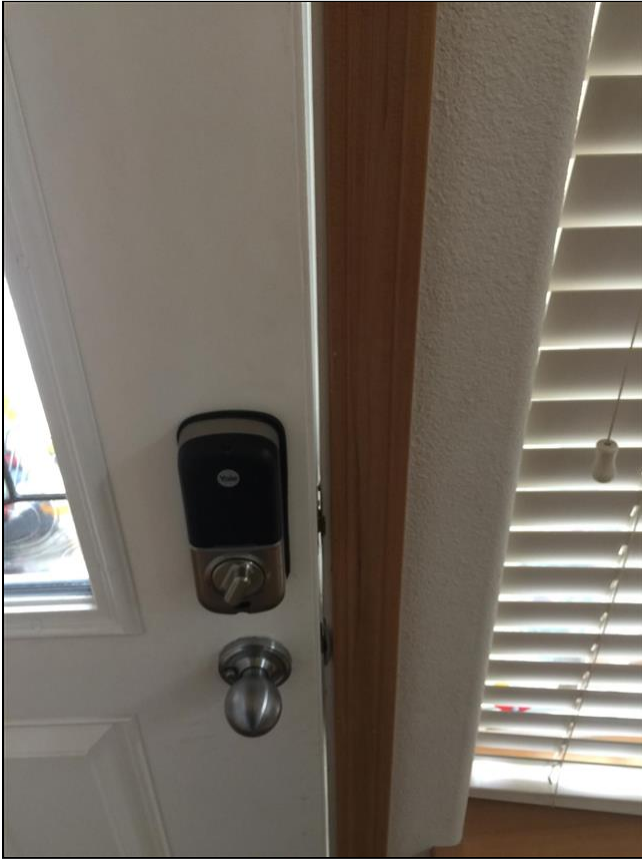
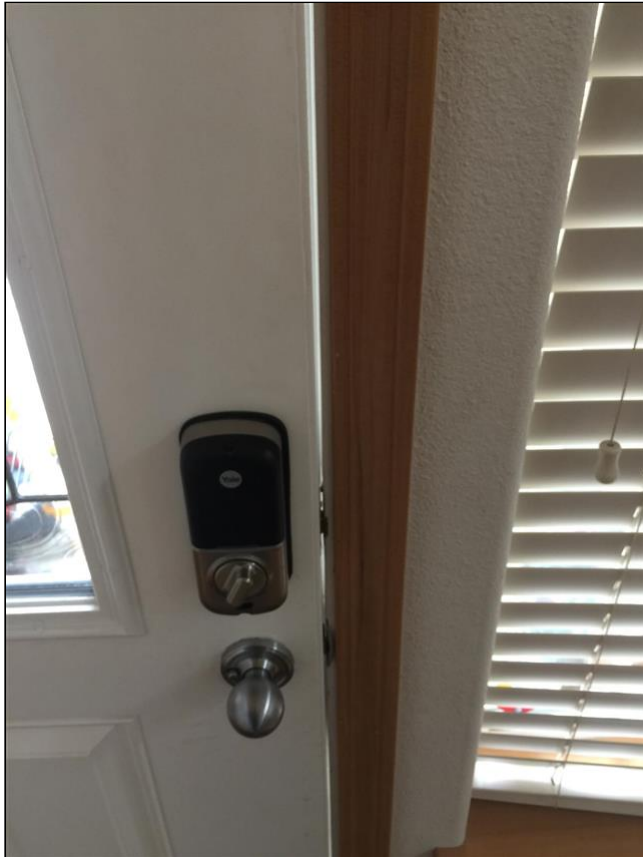
1.1 Item 1(Picture) Front entryway door: Front entryway door did not latch when closed. Recommend readjustment to ensure the door closes and latches smoothly.

1.1 Item 1(Picture) Front entryway door

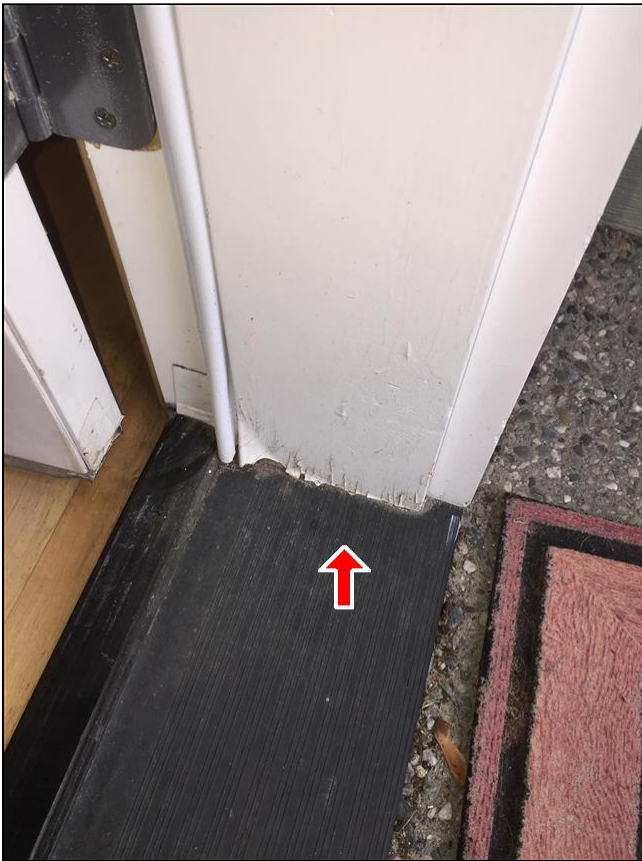
Item 3(Picture) trim paint: Recommend repainting all localized areas where paint was peeling.

1.1 Item 3(Picture) trim paint

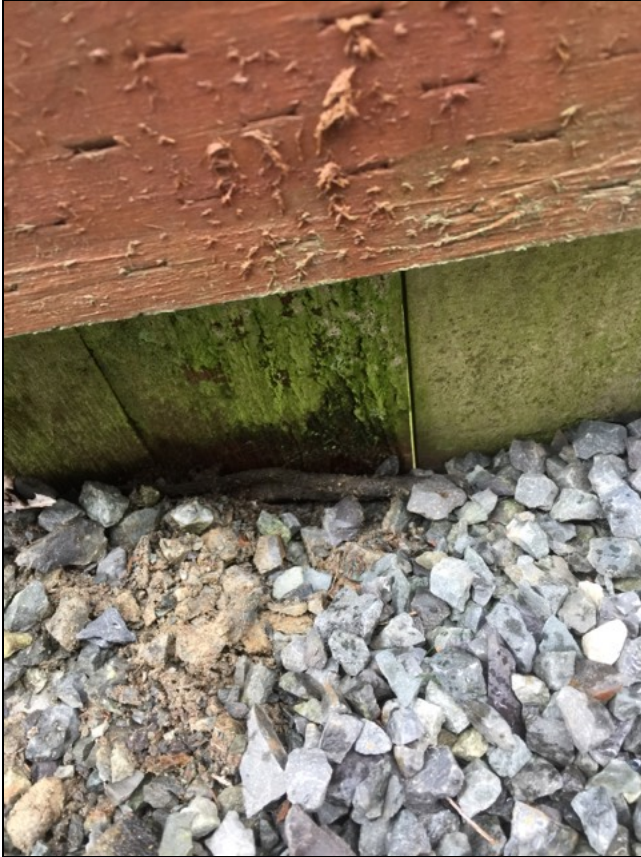
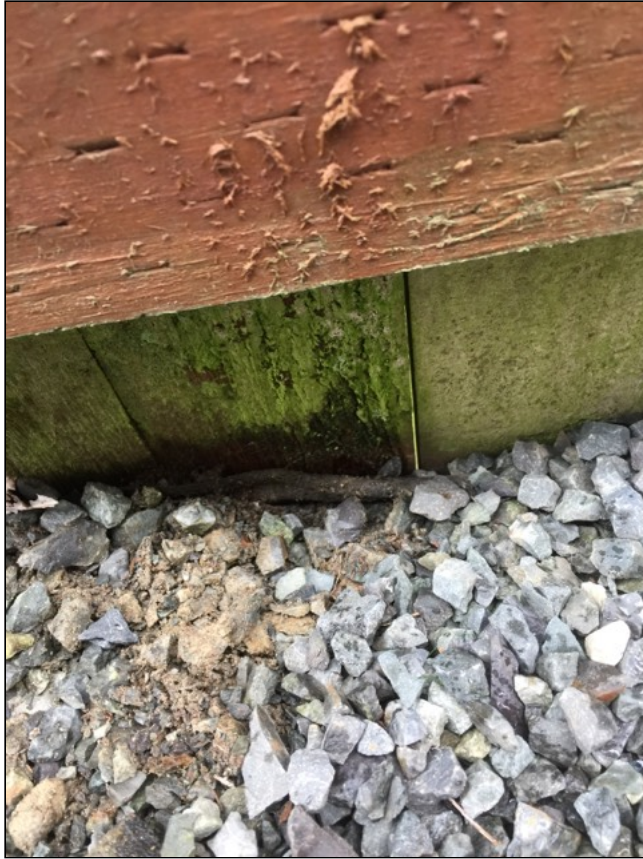
1.3 Item 1(Picture) Fence board wood decay: Some areas of fencing were in contact with the ground. Recommend repair and maintaining a gap between the wood and soil.

1.3 Item 1(Picture) Fence board wood decay

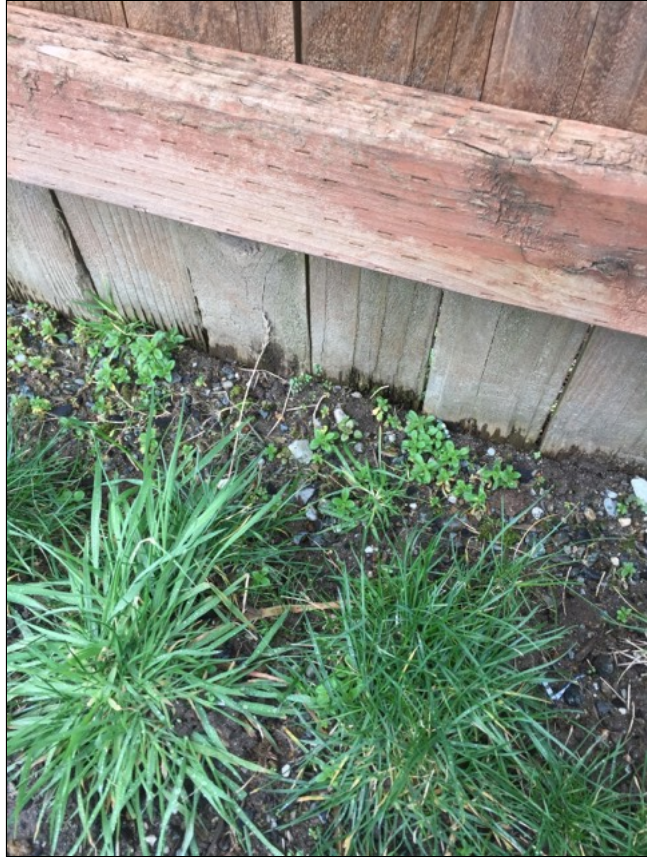
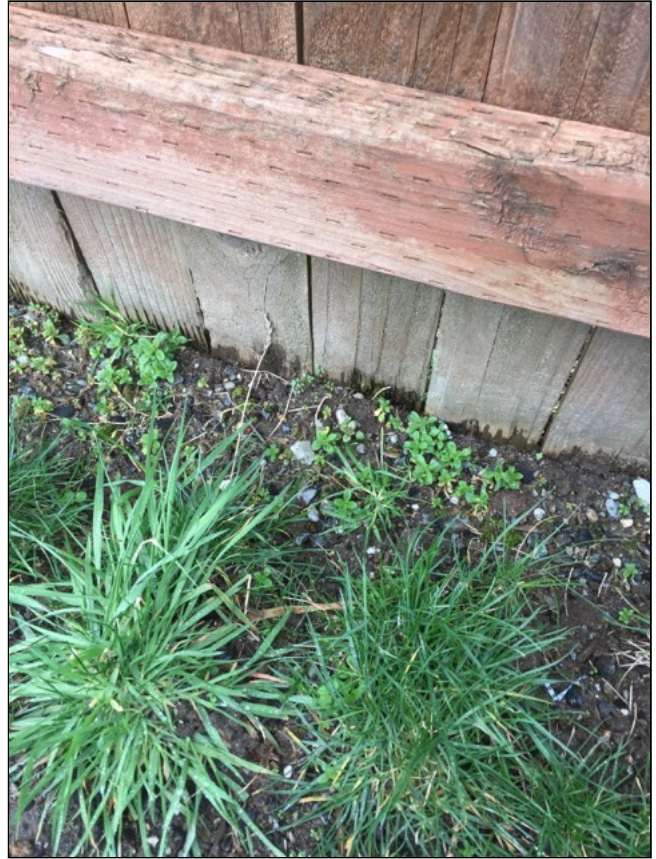
Item 2(Picture) Wood to soil contact.

1.3 Item 2(Picture) Wood to soil contact

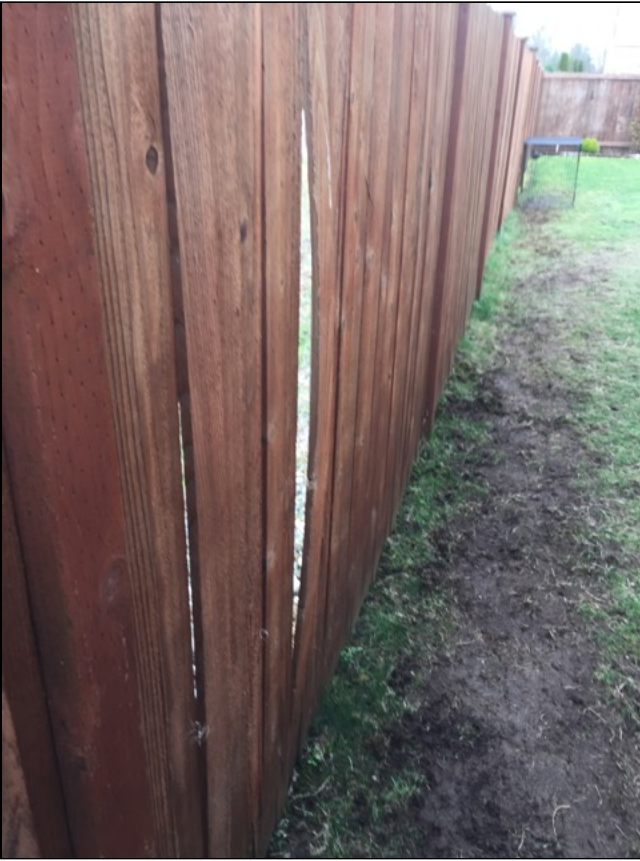
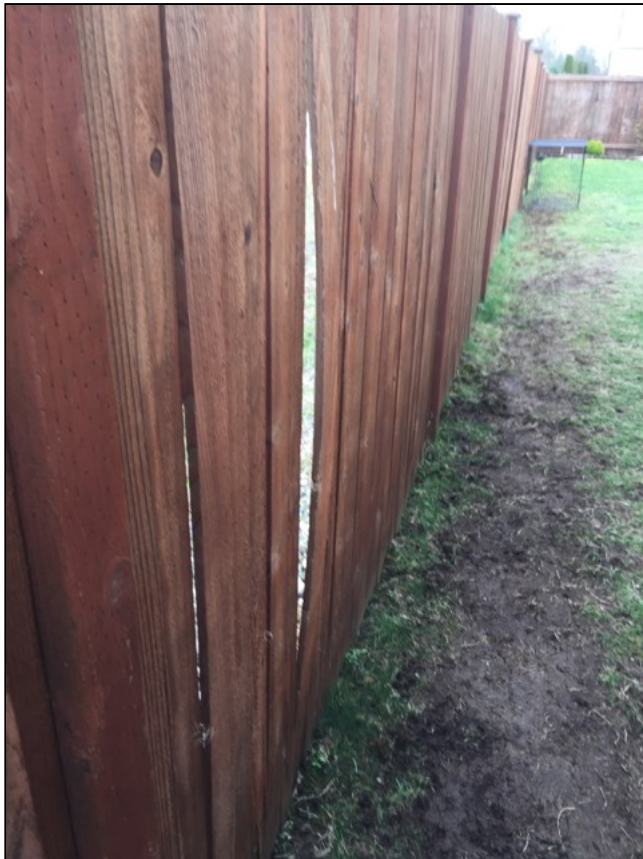
Item 3(Picture) Warped fence boards: Several fence boards were warped. Recommend replacing these boards.

1.3 Item 3(Picture) Warped fence boards

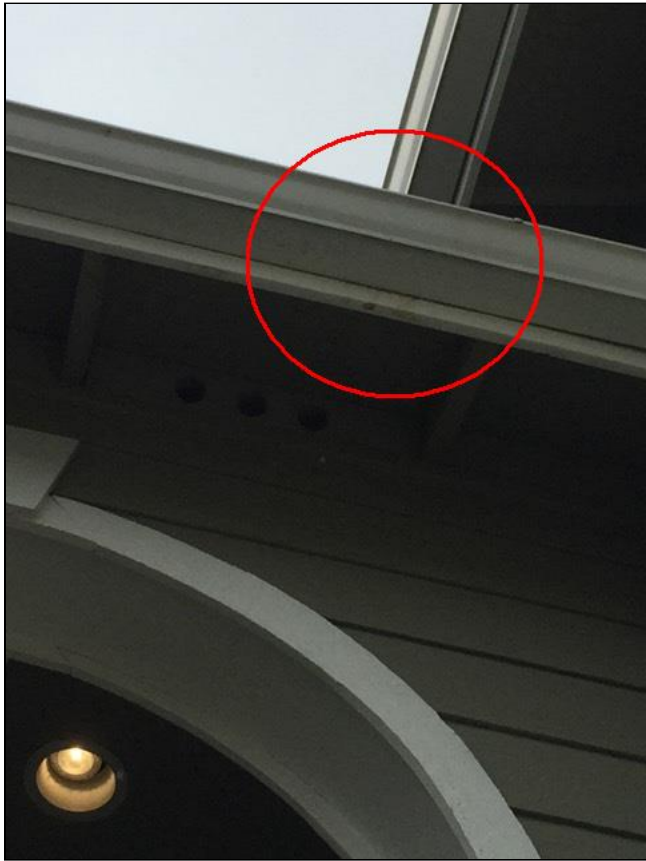
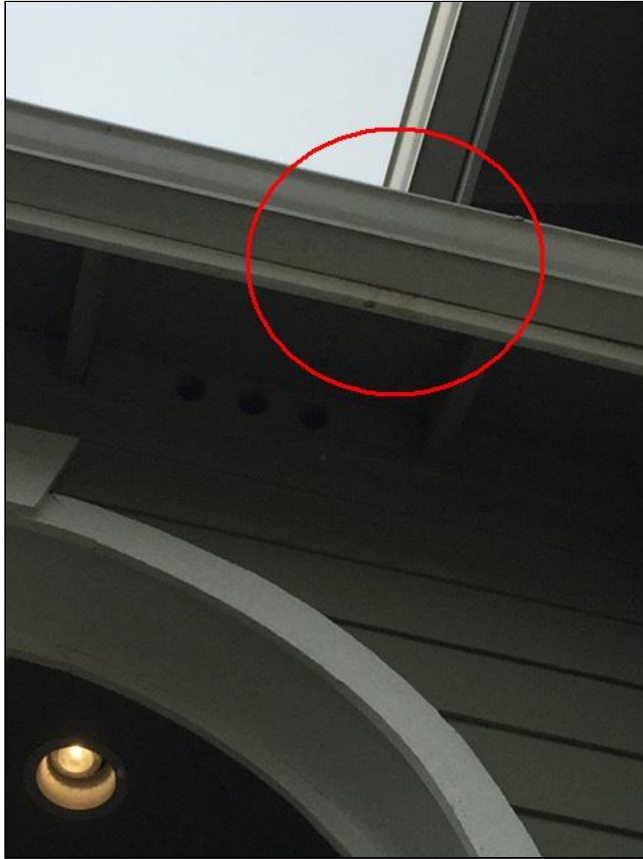
1.5 Item 1(Picture) Possible moisture behind gutter.

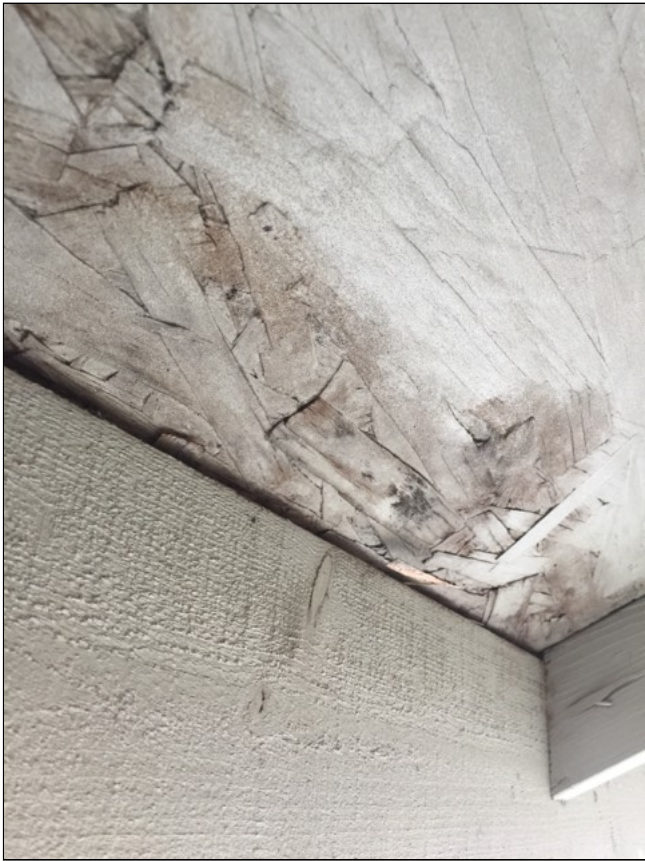
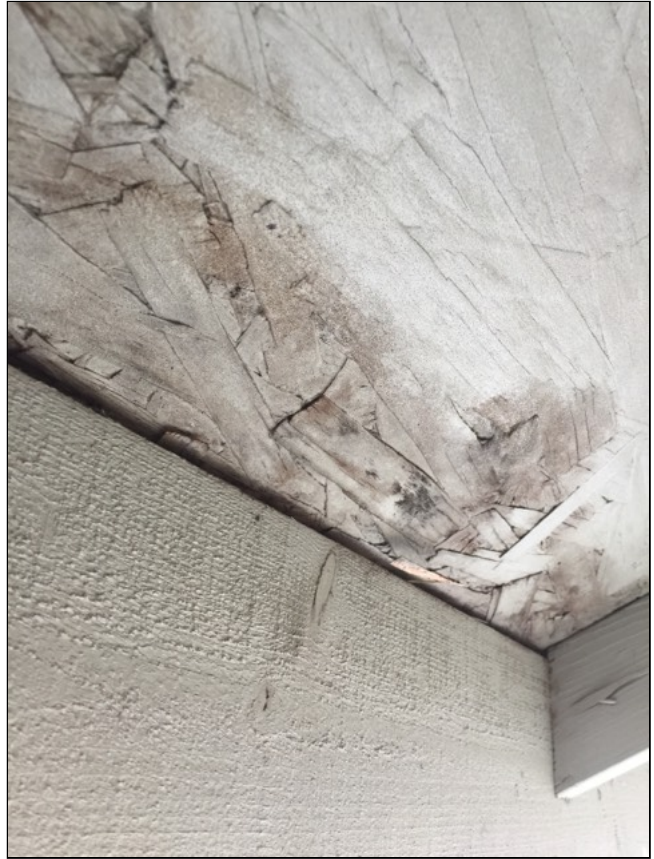
Item 2(Picture) Moisture staining behind gutter and fascia: The North soffit boards had moisture staining and damage from apparent water wicking behind the gutter and fascia boards. Recommend ensuring the water makes it all the way into the gutter.

1.5 Item 2(Picture) Moisture staining behind gutter and fascia

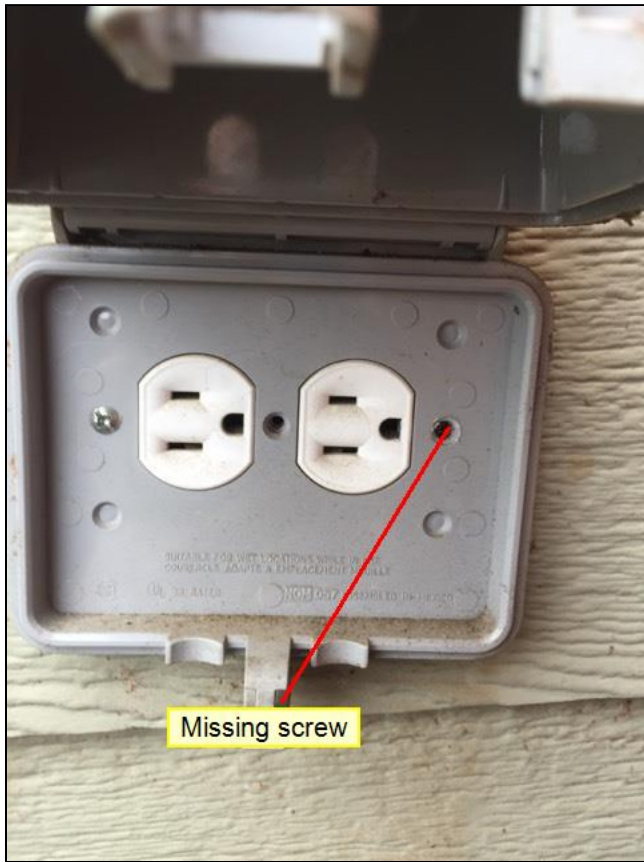
1.7 Item 1(Picture) Missing screw on north receptacle

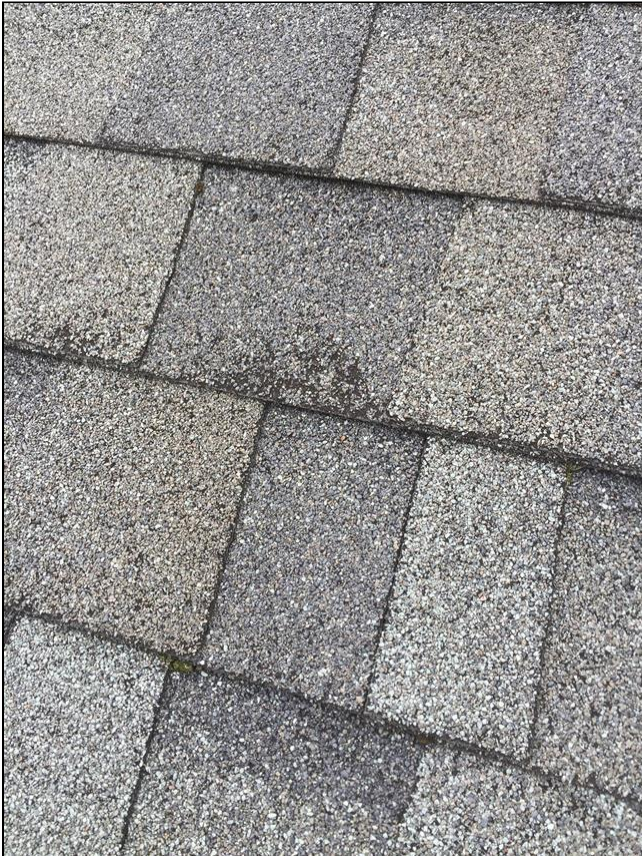
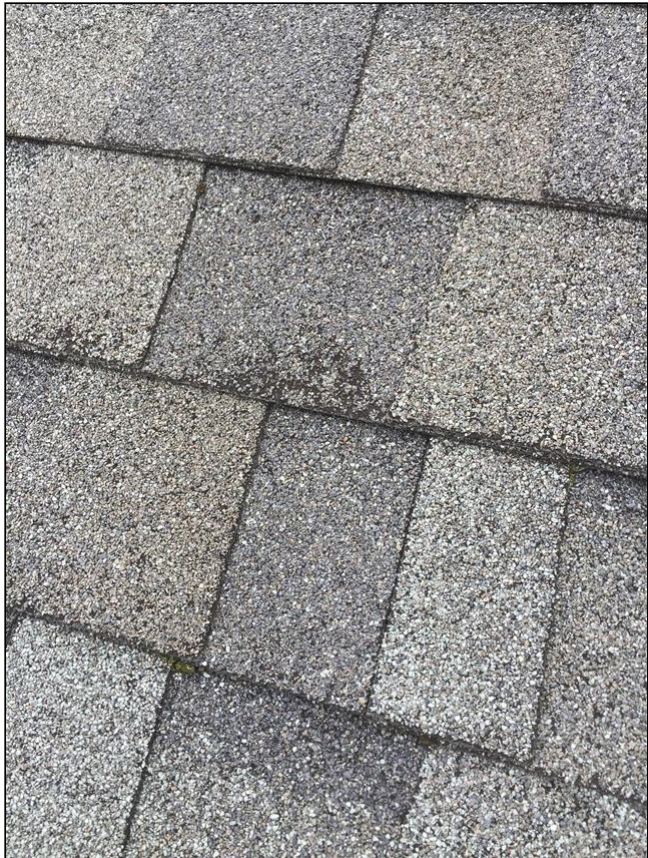
**2.0** Item 1(Picture), The roof covering was a 30 year architectural style roof. It was approximately 10 years old and showed wear commiserate for the age of the roof. There were several areas where there was greater wear and one area at the south slope where the felt was showing below the skylights. Recommend a roofer replace any defective shingles.

2.0 Item 1(Picture) Roof granuals missing

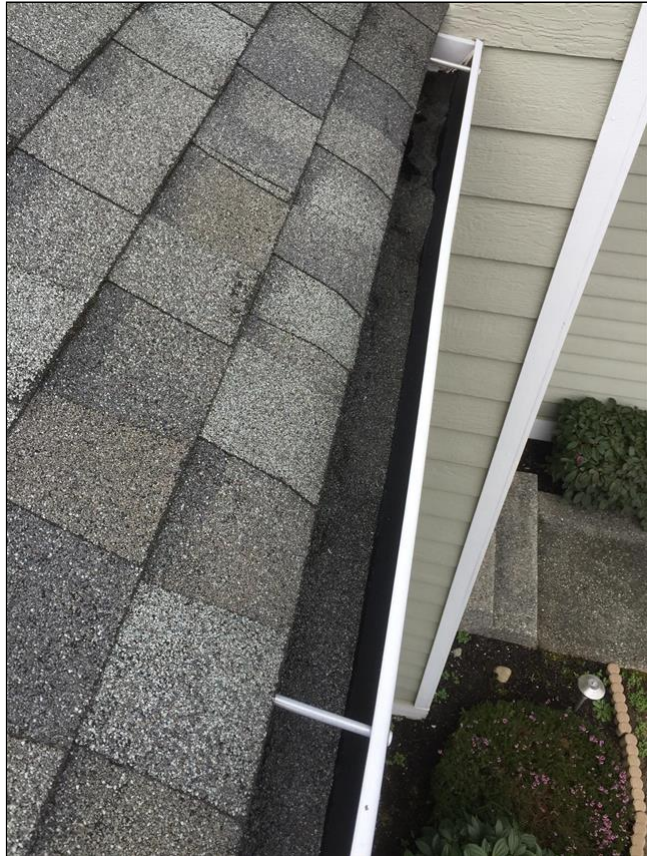
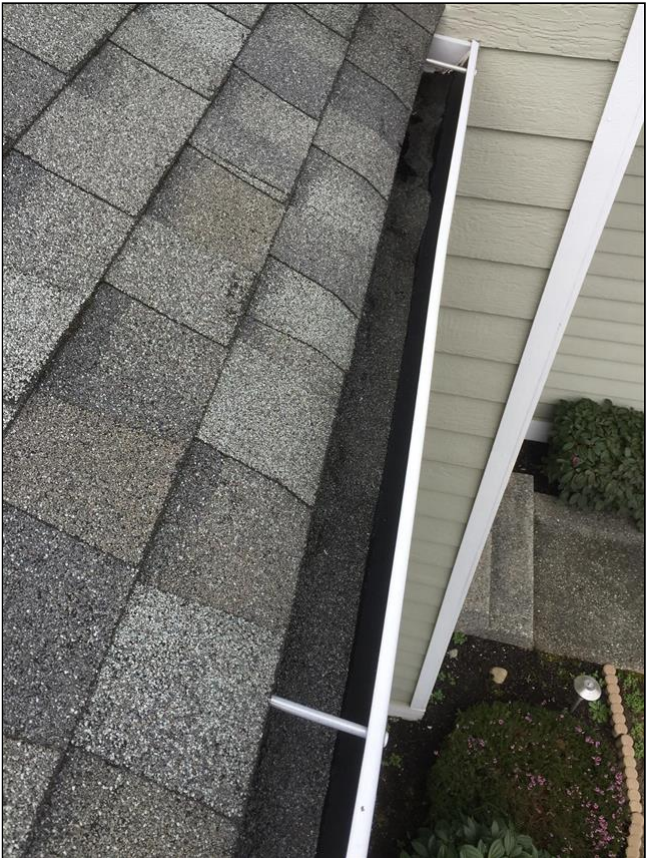
Item 2(Picture) Gutters full of granules: It is possible that this roof has been pressure washed. Recommend removing all granules from the gutters.

2.0 Item 2(Picture) Gutters full of granules

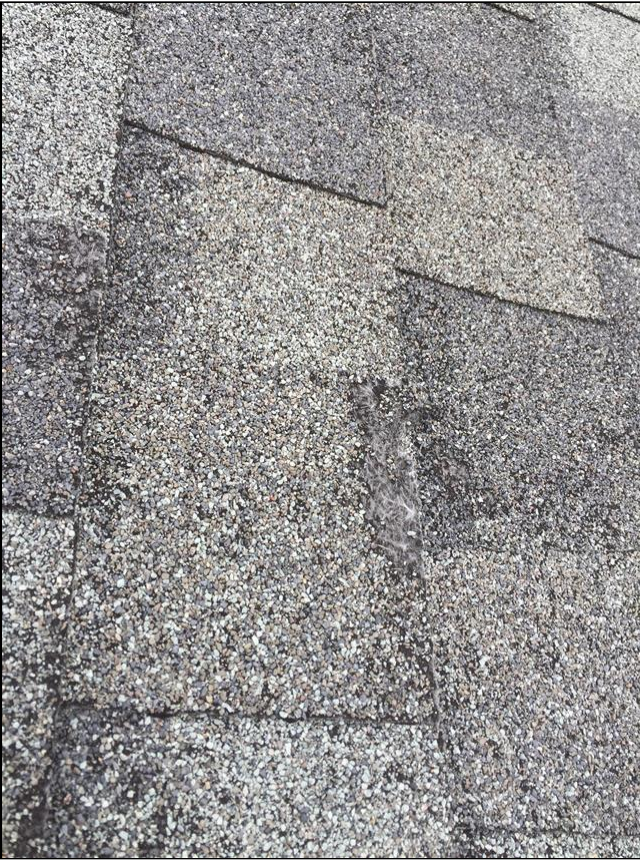
Item 3(Picture) Areas of felt showing

2.0 Item 3(Picture) Areas of felt showing

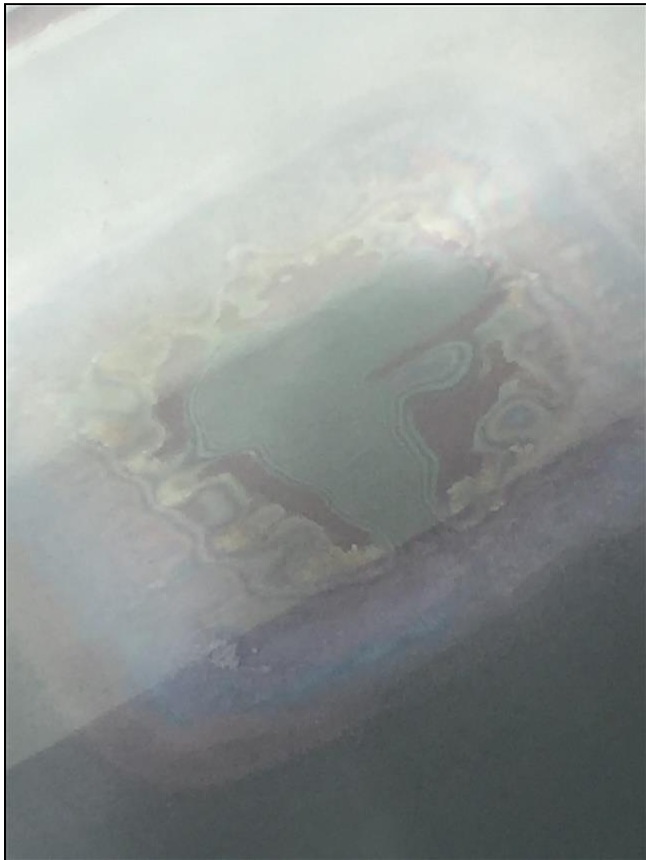
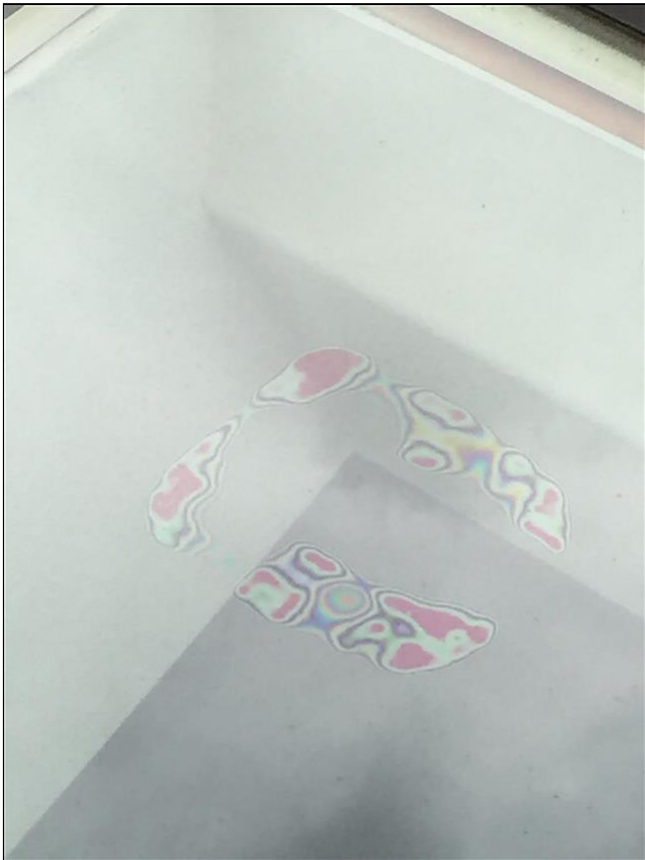
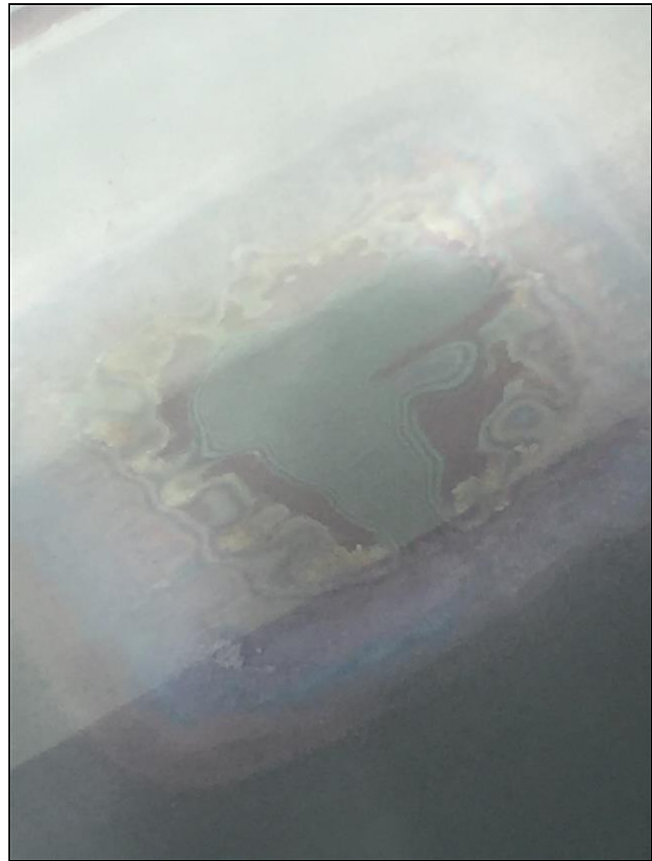
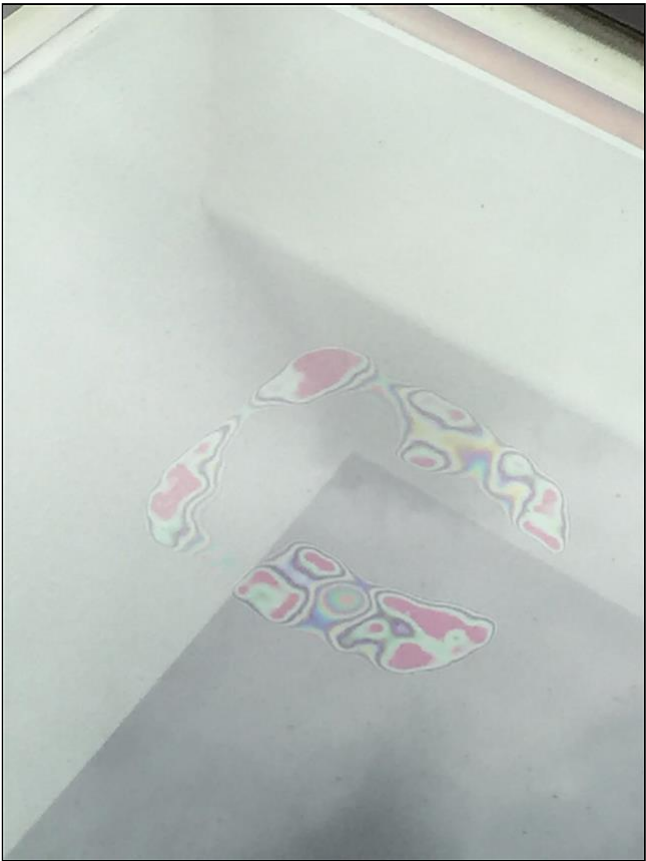
2.2 Item 1(Picture) Skylight defect: Two of the three skylights had either seal leaks or glazing defects. Recommend a further evaluation by a licensed window contractor.

2.2 Item 1(Picture) Skylight defect

2.2 Item 2(Picture) Skylight defect

Item 1(Picture) Skylight defect: Two of the three skylights had either seal leaks or glazing defects. Recommend a further evaluation by a licensed window contractor.

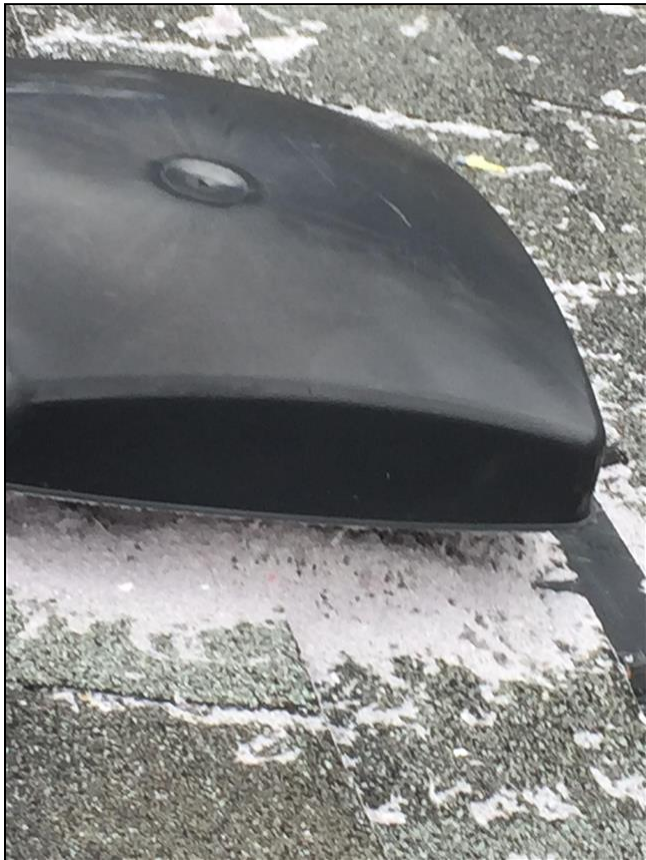
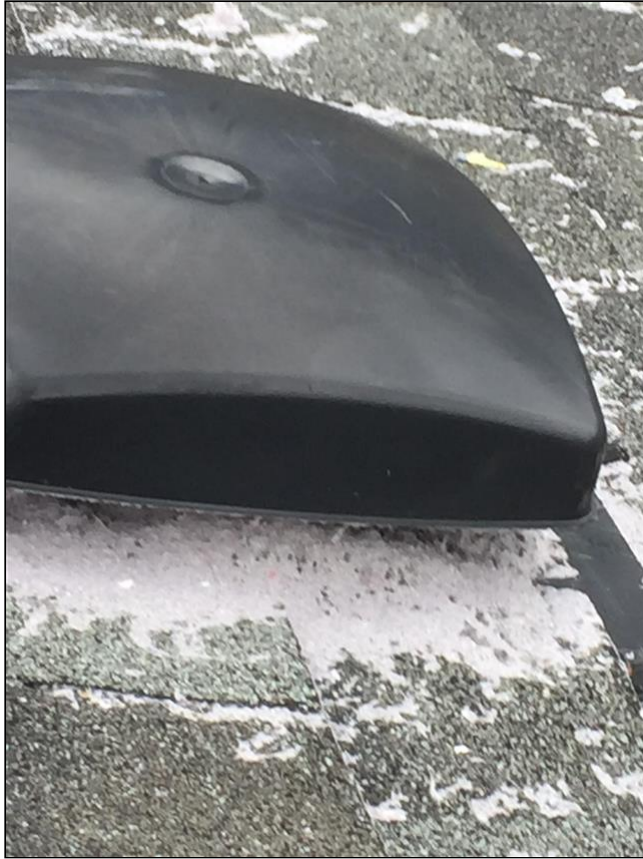
2.3 Item 1(Picture) Dryer venting lint onto the roof: The dryer vent appeared to be full of lint. Recommend cleaning the dryer vent pipe out and ensuring there is no residual lint in the pipe.

2.3 Item 1(Picture) Dryer venting lint onto the roof

Item 1(Picture) Dryer venting lint onto the roof: The dryer vent appeared to be full of lint. Recommend cleaning the dryer vent pipe out and ensuring there is no residual lint in the pipe.

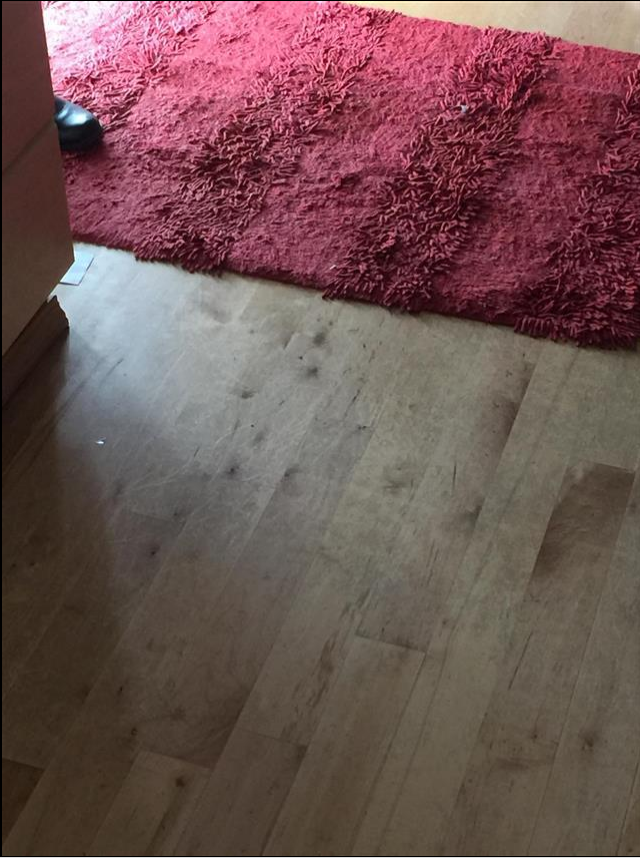
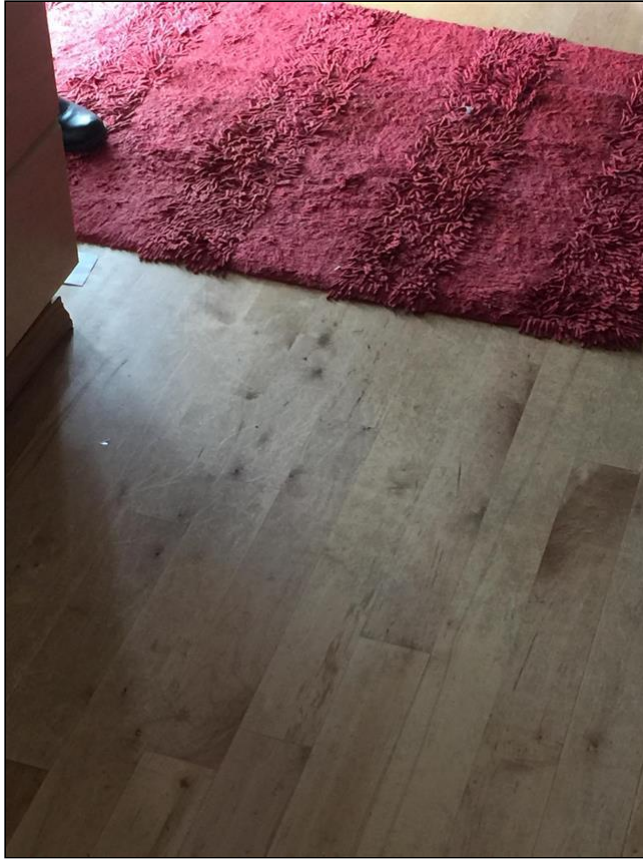
**3.2 Item 1(Picture) Dog claw marks:** There were various places where the floor appeared to have been marked up by the dog's claws. Recommend repair or replace.

3.2 Item 1(Picture) Dog claw marks

Item 1(Picture) Dog claw marks: There were various places where the floor appeared to have been marked up by the dog's claws. Recommend repair or replace.

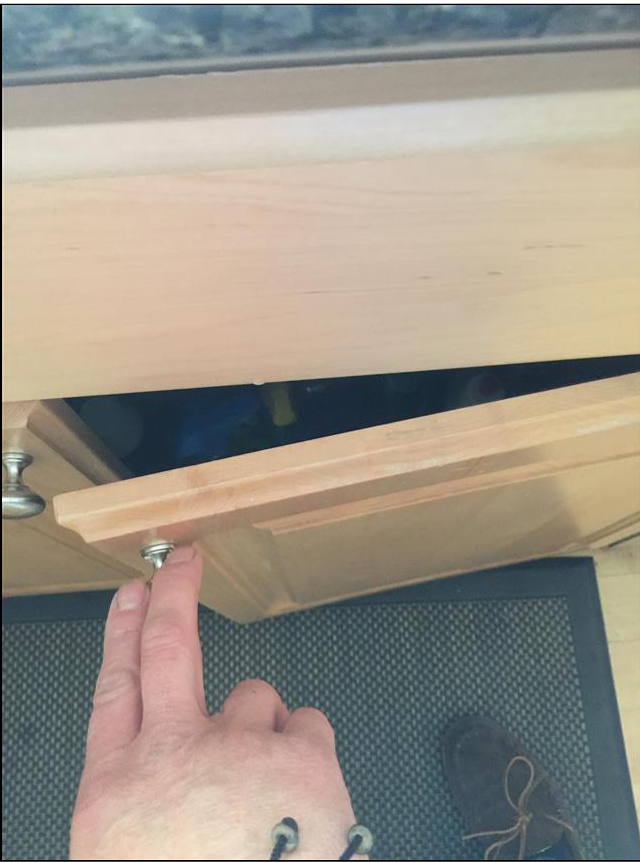
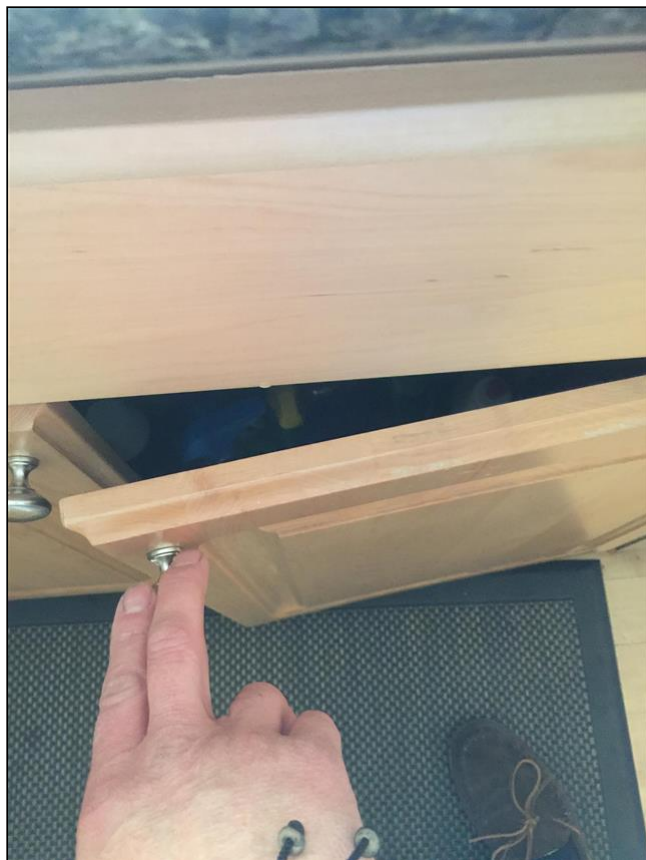
3.5 Item 1(Picture) Warped cabinet door under the sink: Recommend repair or replace.

3.5 Item 1(Picture) Warped cabinet door under the sink

Item 1(Picture) Warped cabinet door under the sink: Recommend repair or replace.

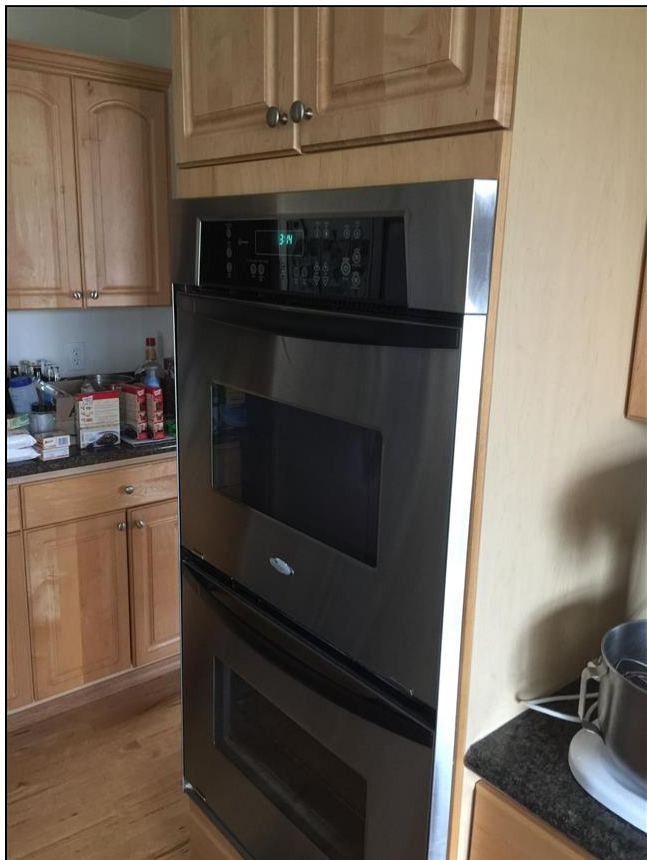
**3.10** Item 1(Picture) Convection fan noise: The oven convection fan appeared to be noisier that typical. Recommend further evaluation by an appliance specialist.

3.10 Item 1(Picture) Convection fan noise:

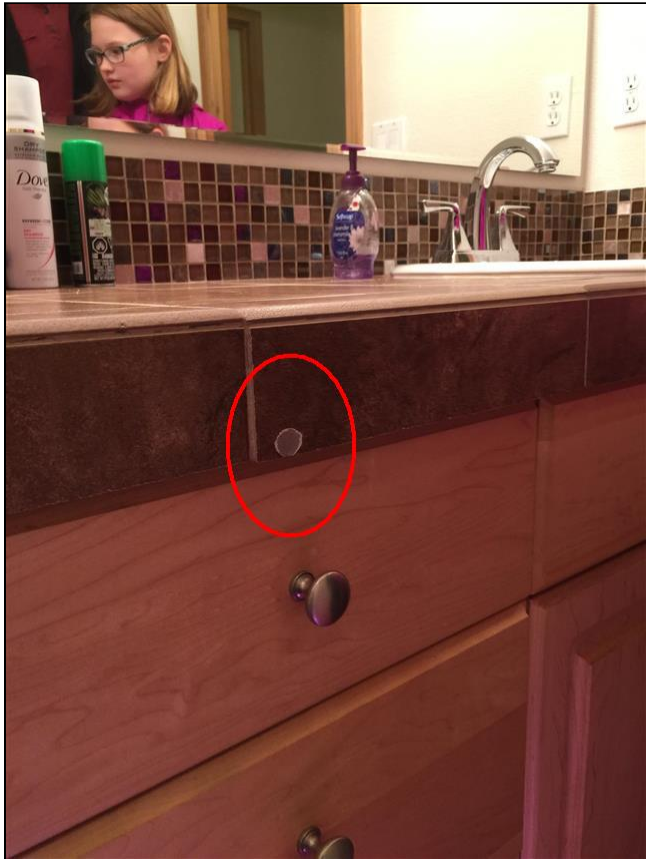
4.0 Item 1(Picture) Chip in counter
