# Inspection Report

**Property Address:**  
1234 79th Dr. N.E.  
Seattle WA 98223

**Sound Choice Home Inspections**

<b>Date:</b> 3/12/2017	<b>Time:</b> 02:30 PM	<b>Report ID:</b> 123417 79
<b>Property:</b> 1234 79th Dr. N.E. Seattle WA 98223	<b>Customer:</b> Joe Sknovich	<b>Real Estate Professional:</b>

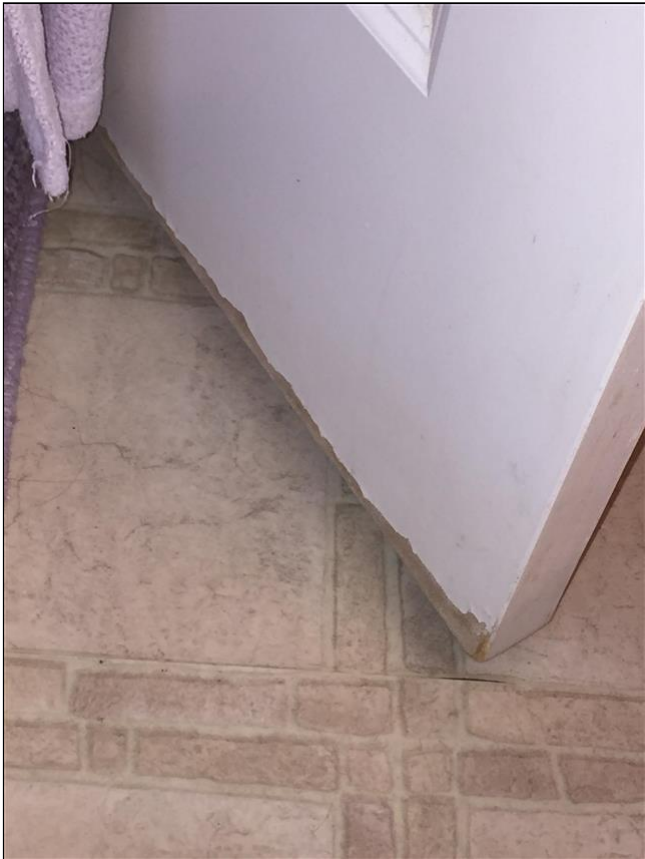
Item 2(Picture) Bathroom door moisture damage

4.0 Item 2(Picture) Bathroom door moisture damage

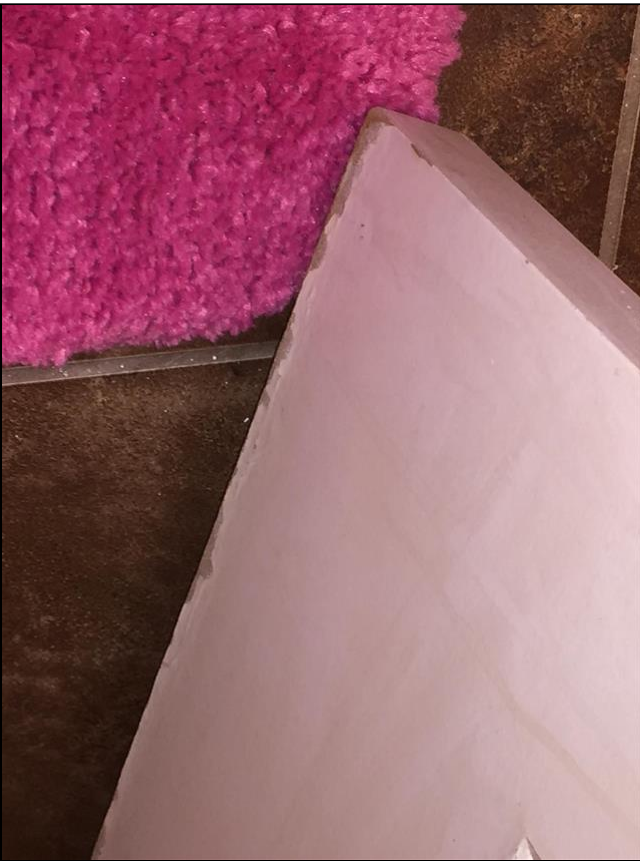
Item 3(Picture) Bathroom door moisture damage

4.0 Item 3(Picture) Bathroom door moisture damage

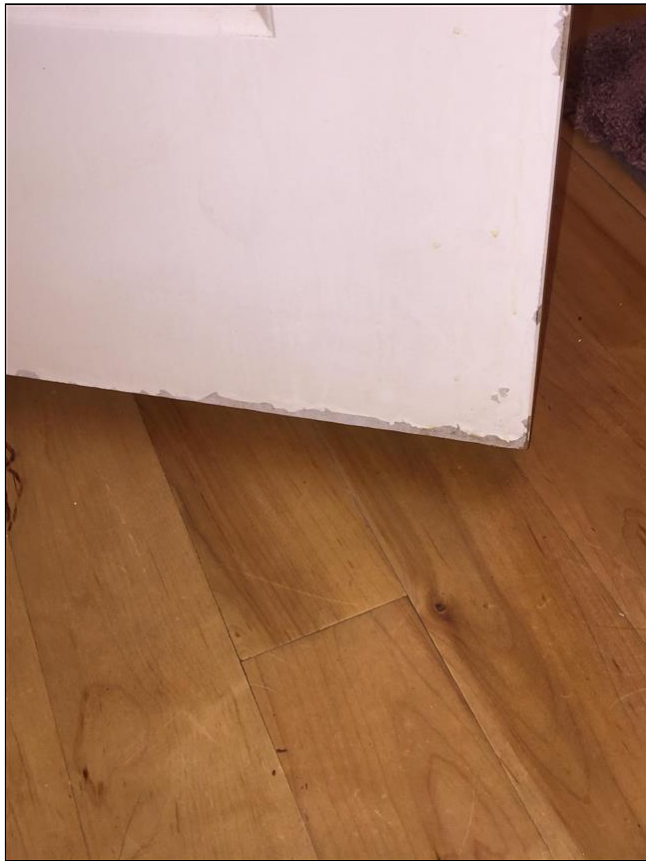
Item 4(Picture) Bathroom door moisture damage

4.0 Item 4(Picture) Bathroom door moisture damage

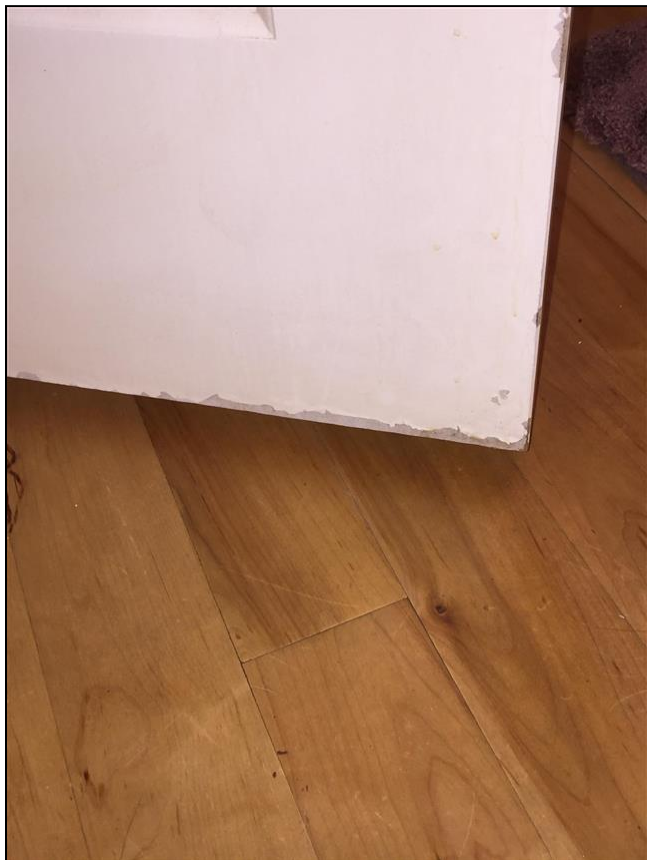
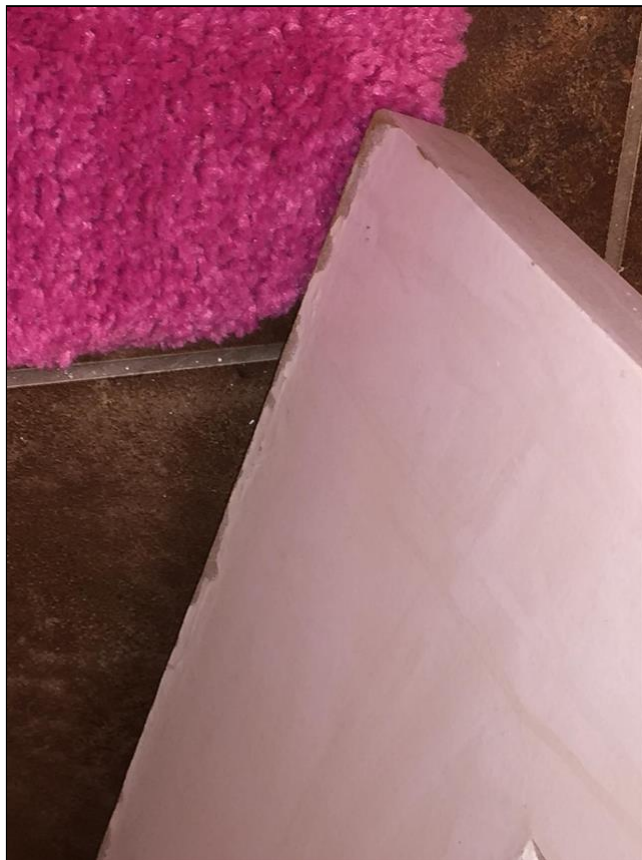
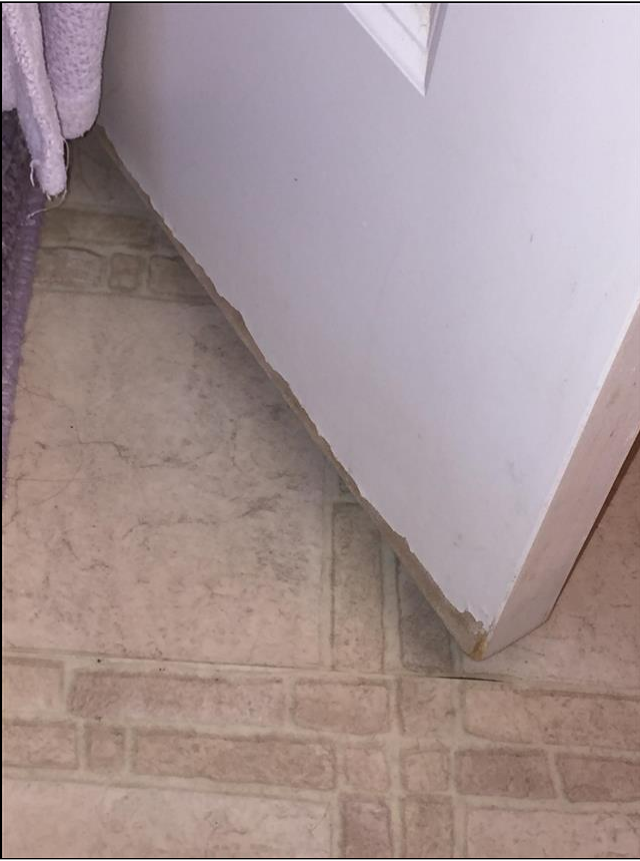
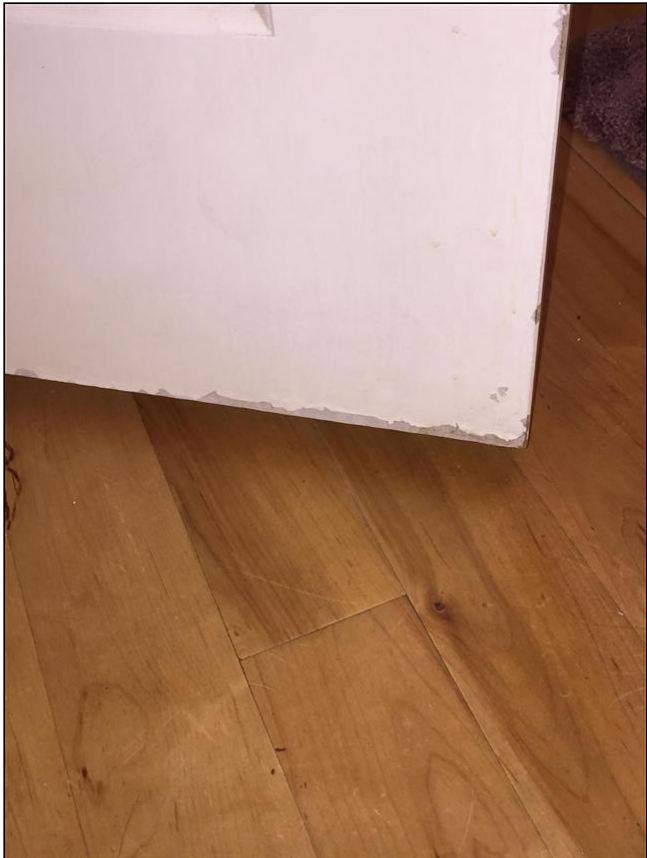
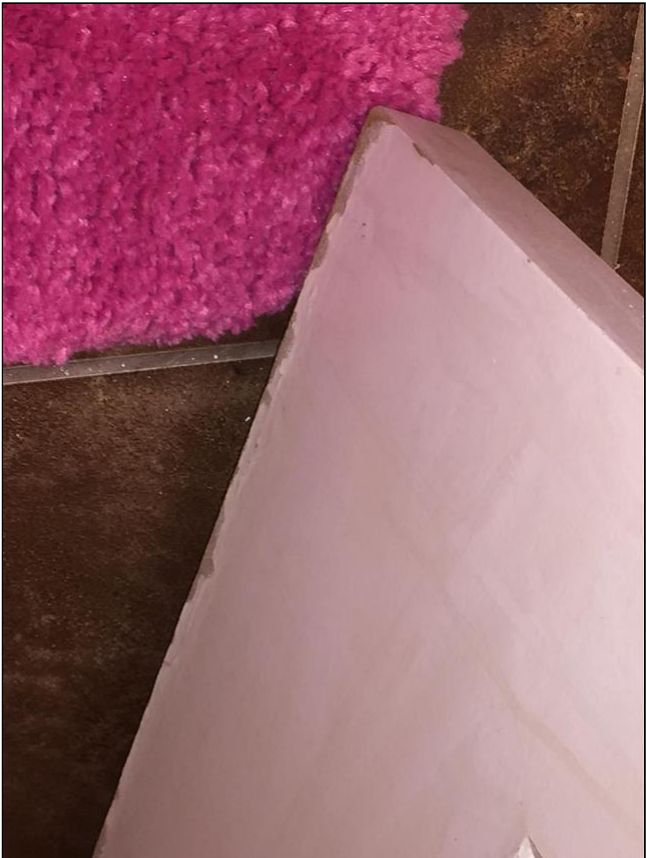
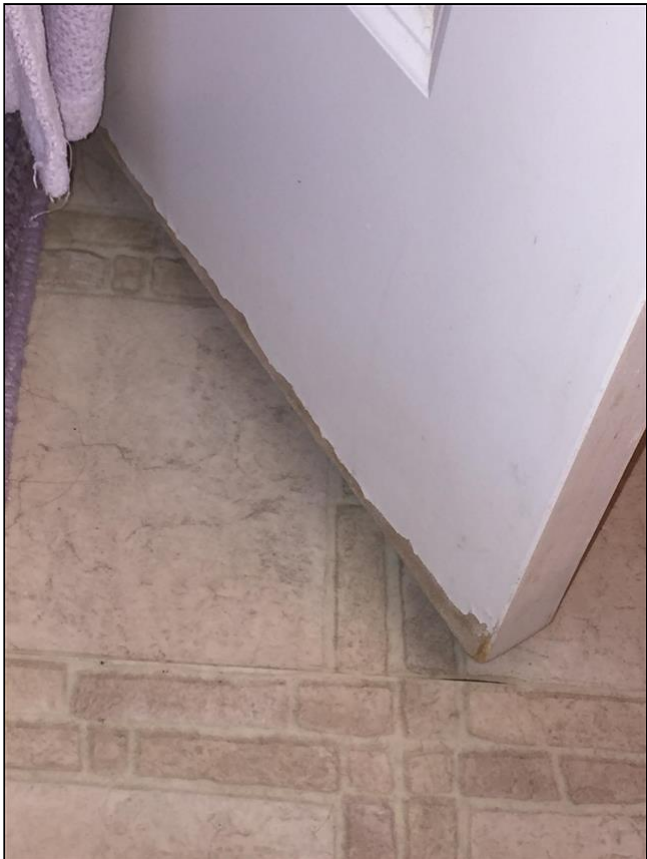
**4.3** Item 1(Picture), Item 2(Picture) Item 3(Picture) Bottom of bathroom door damage: All three bathroom doors appeared to have moisture damage at the bottom of the doors. Recommend repair.

4.3 Item 1(Picture) Bottom of bathroom door damage

4.3 Item 3(Picture) Bottom of bathroom door damage

Item 1(Picture), Item 2(Picture) Item 3(Picture) Bottom of bathroom door damage: All three bathroom doors appeared to have moisture damage at the bottom of the doors. Recommend repair.

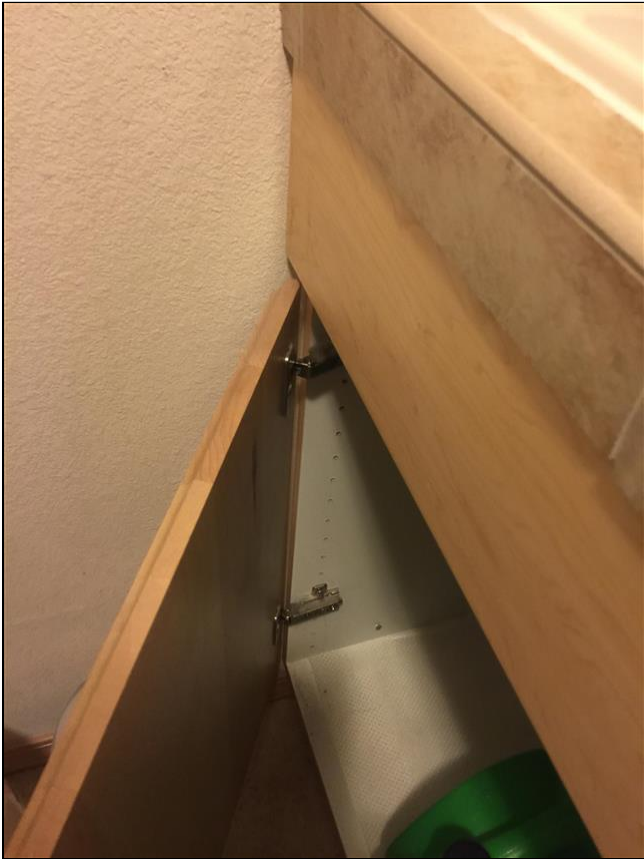
5.0 Item 1(Picture) Loose cabinet door

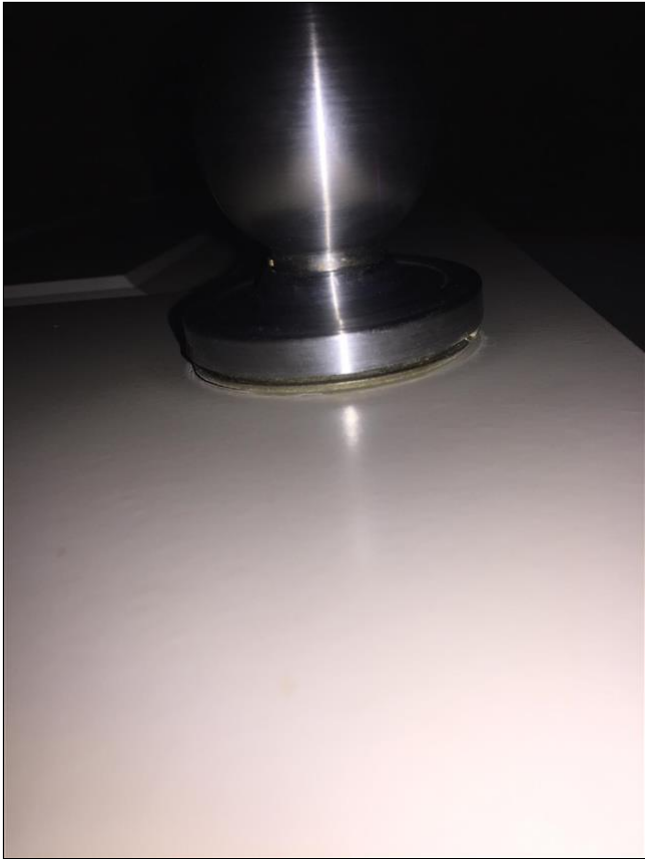
Item 2(Picture) Loose door knob plate North bedroom

5.0 Item 2(Picture) Loose door knob plate

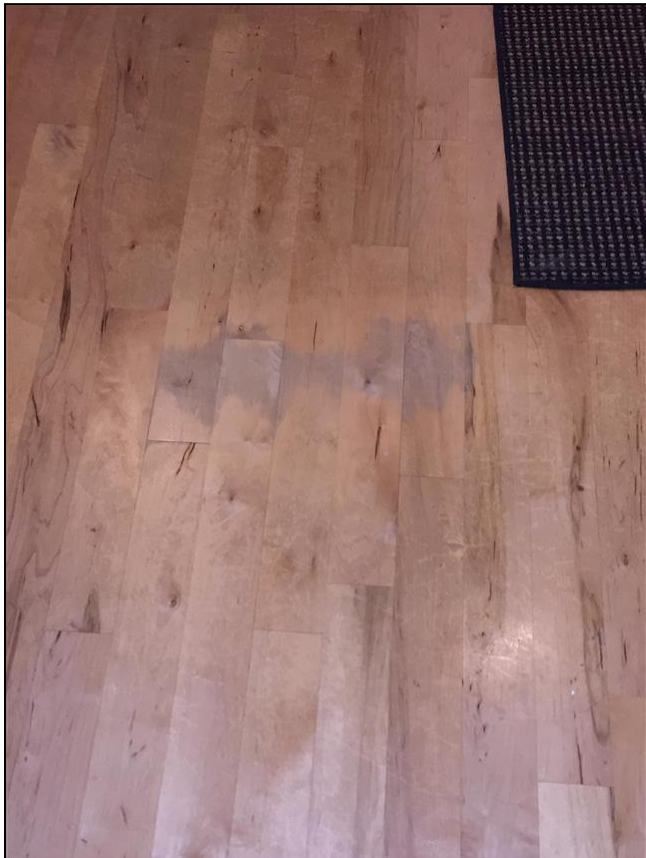
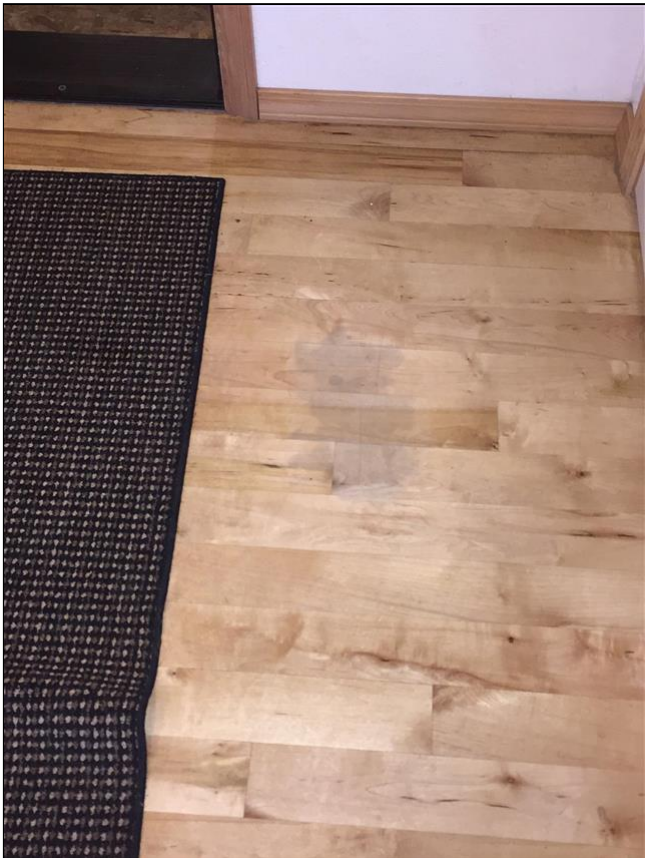
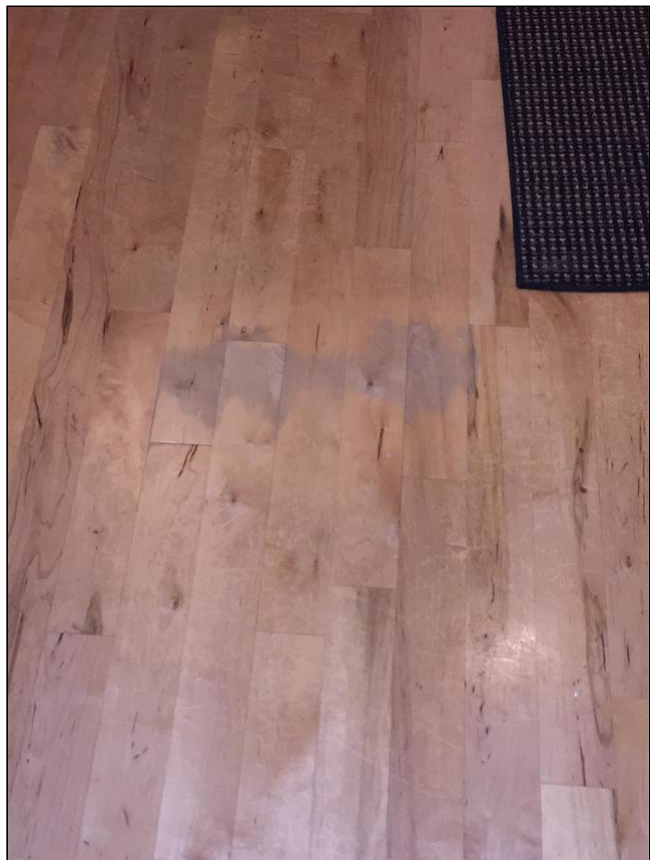
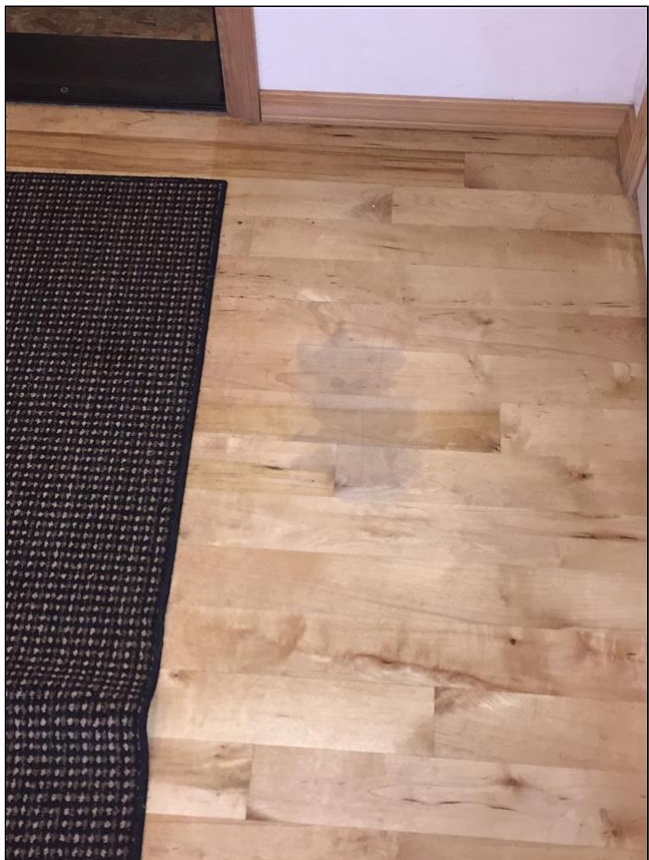
5.2 Item 1(Picture) Moisture staining, Item 2(Picture) Moisture staining: The first floor hallway had apparent moisture staining. Recommend repair.

5.2 Item 1(Picture) Moisture staining

5.2 Item 2(Picture) Moisture staining

Item 1(Picture) Moisture staining, Item 2(Picture) Moisture staining: The first floor hallway had apparent moisture staining. Recommend repair.

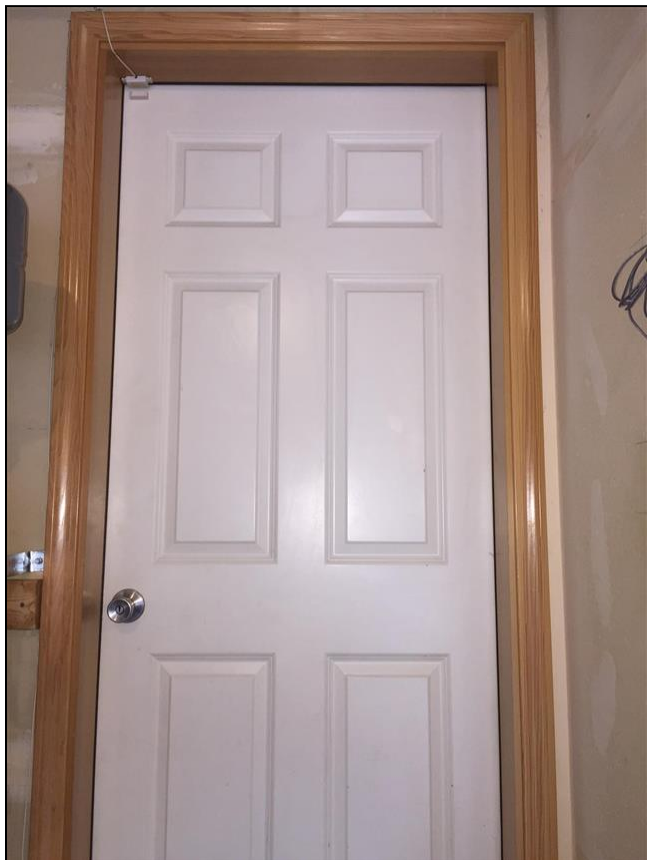
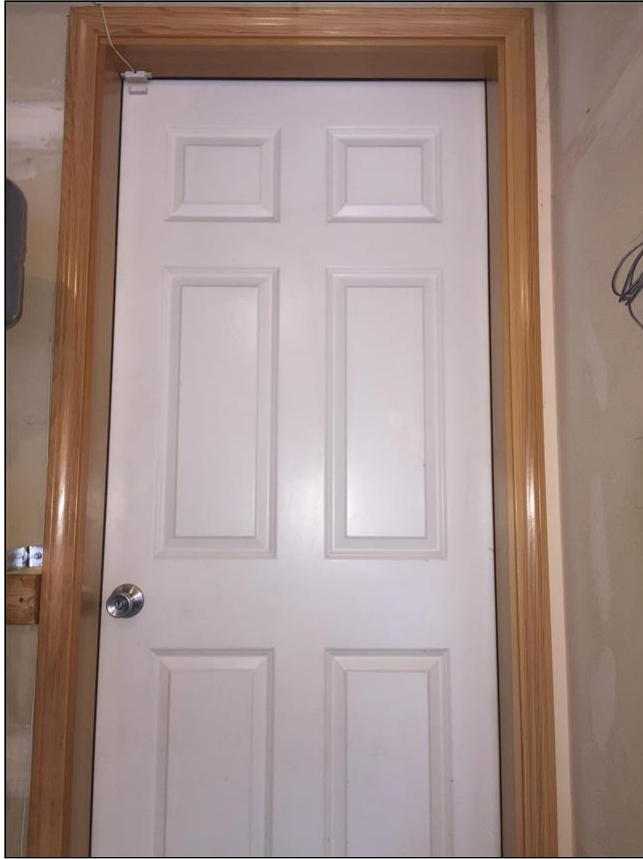
**7.5** Item 1(Picture) Occupant door not self closing: Occupant door to the garage was not a self closing door. Recommend installing spring loaded hinges to ensure this is a self closing door.

7.5 Item 1(Picture) Occupant door not self closing

Item 1(Picture) Occupant door not self closing: Occupant door to the garage was not a self closing door. Recommend installing spring loaded hinges to ensure this is a self closing door.

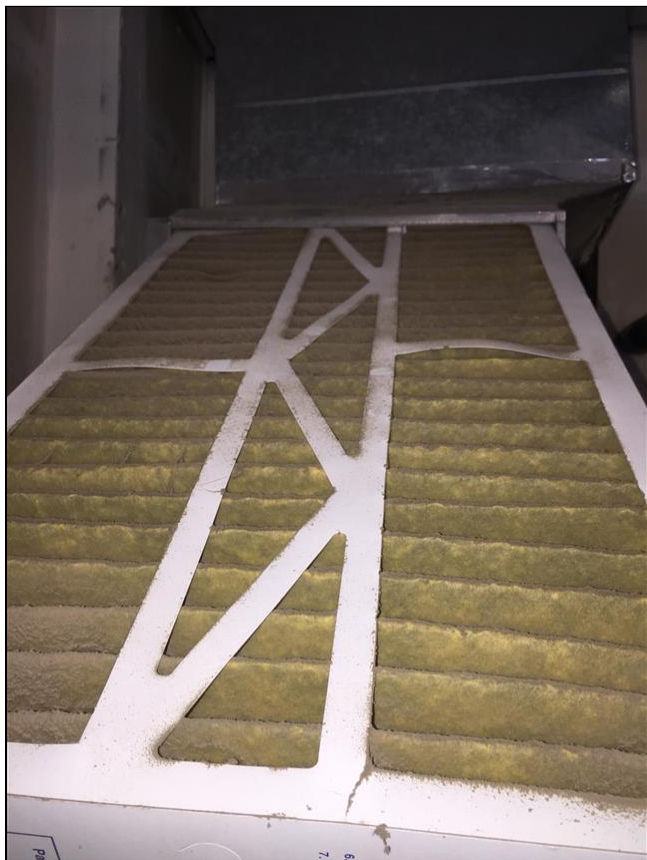
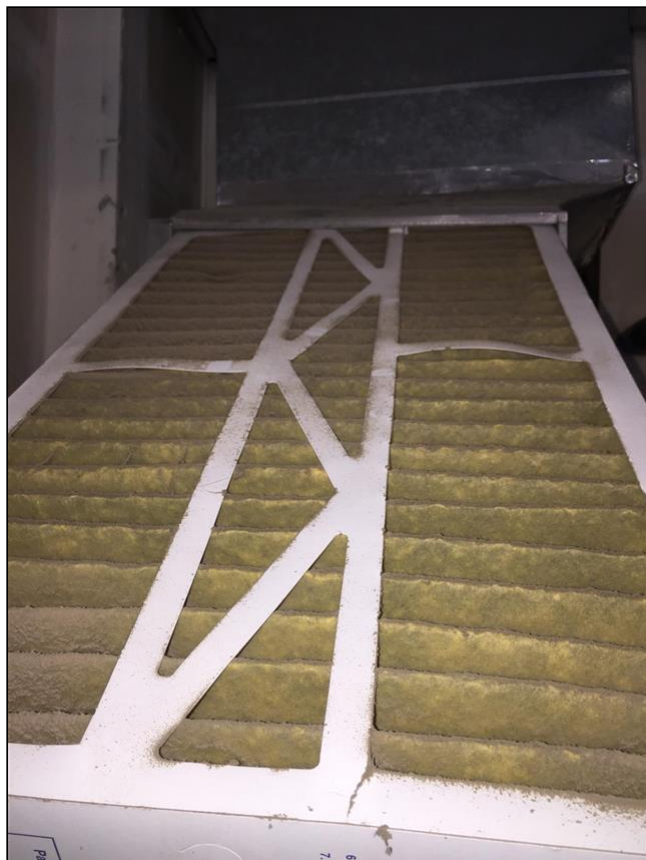
10.3 Item 1(Picture)

10.3 Recommend replacing furnace filter.

Recommend replacing furnace filter.
