# Inspection Report

**Property Address:**  
1234 79th Dr. N.E.  
Seattle WA 98223

**Sound Choice Home Inspections**

<b>Date:</b> 3/12/2017	<b>Time:</b> 02:30 PM	<b>Report ID:</b> 123417 79
<b>Property:</b> 1234 79th Dr. N.E. Seattle WA 98223	<b>Customer:</b> Joe Sknovich	<b>Real Estate Professional:</b>

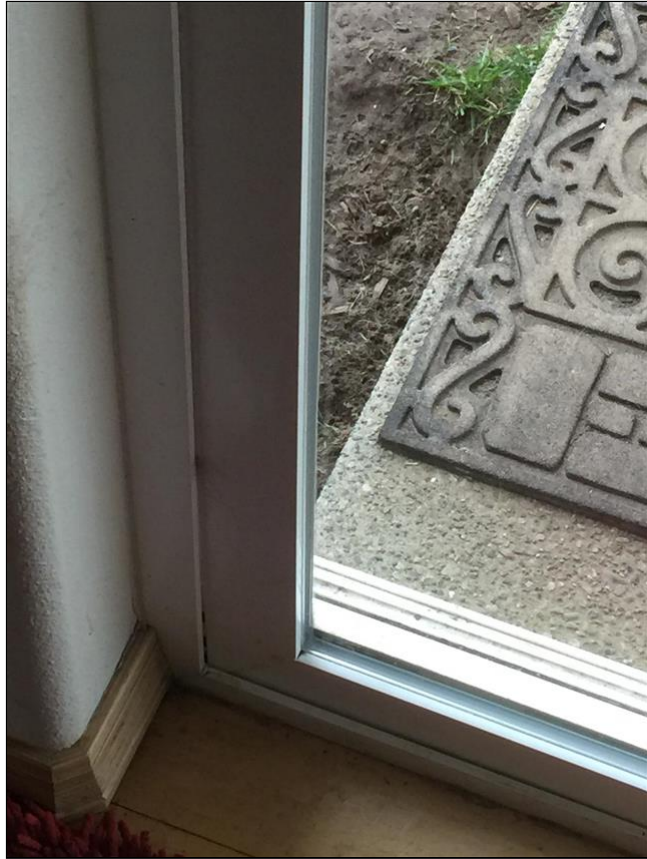
1.1 Item 2(Picture) Rear sliding door

Item 2(Picture) Rear sliding door: Rear sliding door did not close smoothly. Recommend repair by a licensed window contractor.

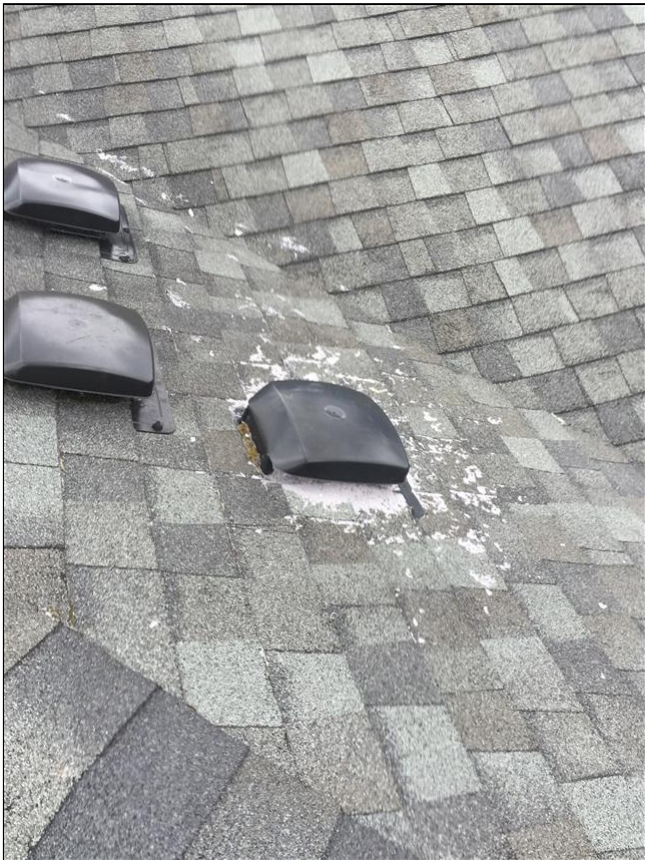
2.3 Item 2(Picture) Dryer vent

2.3 Item 1(Picture) Dryer venting lint onto the roof: The dryer vent appeared to be full of lint. Recommend cleaning the dryer vent pipe out and ensuring there is no residual lint in the pipe.

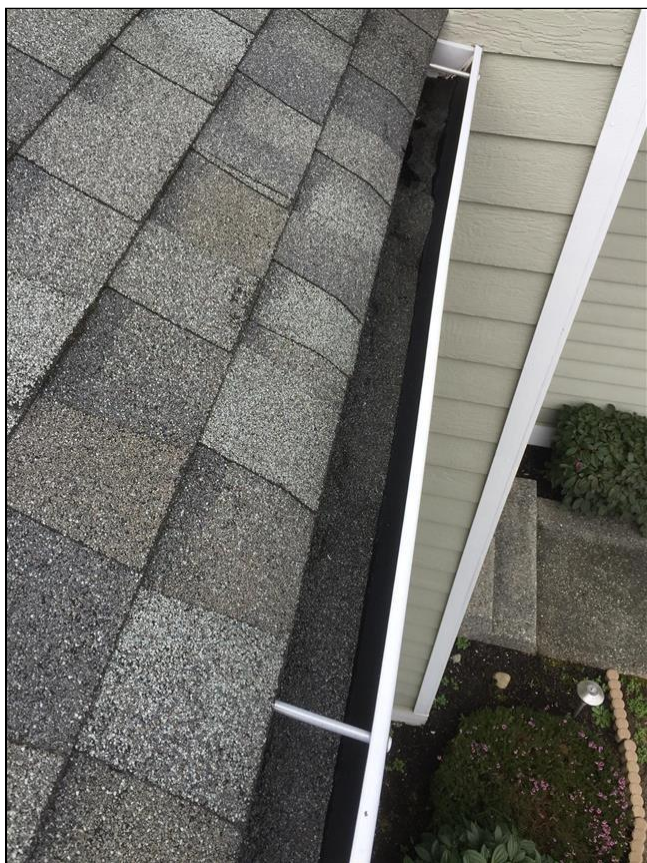
Item 2(Picture) Gutters full of granules: It is possible that this roof has been pressure washed. Recommend removing all granules from the gutters.

**2.4** Item 1(Picture) Granules in the gutter. See comments on roof coverings.

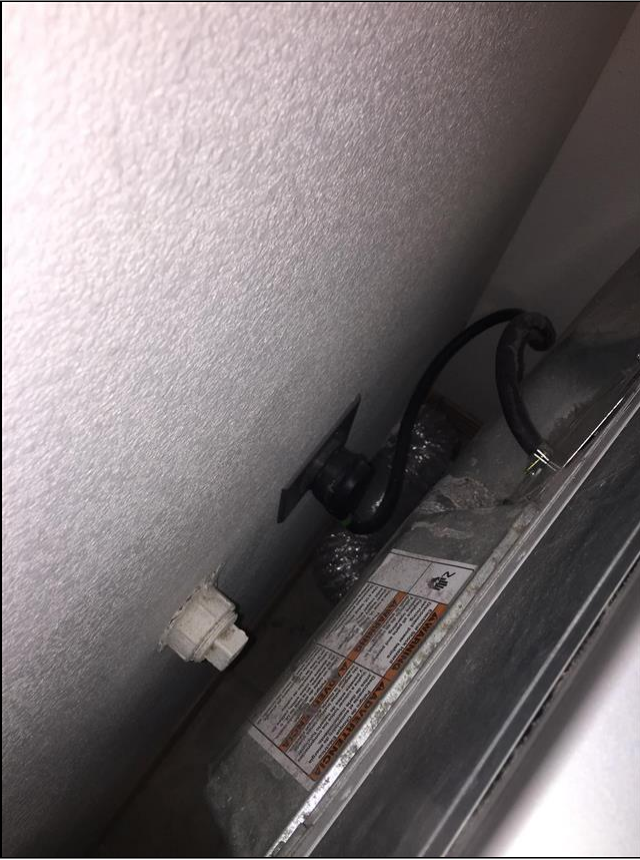
**3.15** Item 1(Picture) See roof vent comments

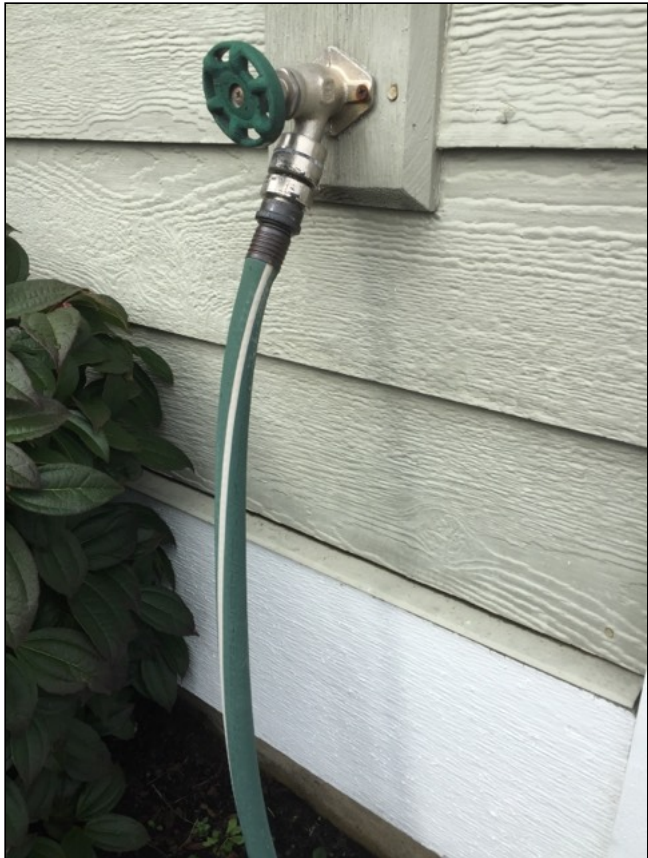
1.0 Item 3(Picture) Soft siding

Item 3(Picture) Soft siding: The bottom siding board under the front hose bib was soft at the bottom. REcommend monitoring and keeping this area protected from moisture from the hose bib.

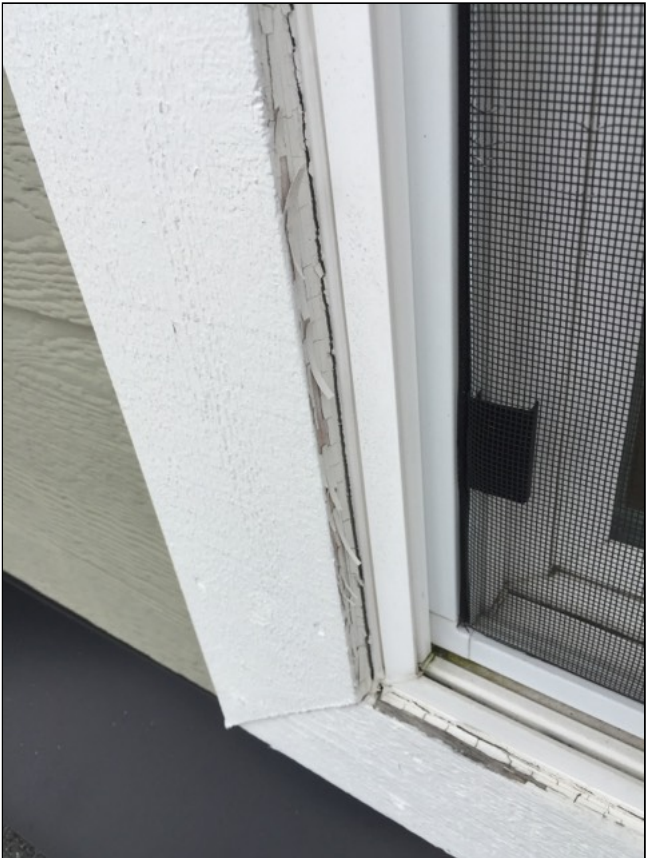
1.0 Item 4(Picture) Window trim caulking

Item 4(Picture) Window trim caulking: Moisture can collect on these trim boards and ledges. Recommend maintenance caulking at all ledges, utility penetrations, and trim boards.

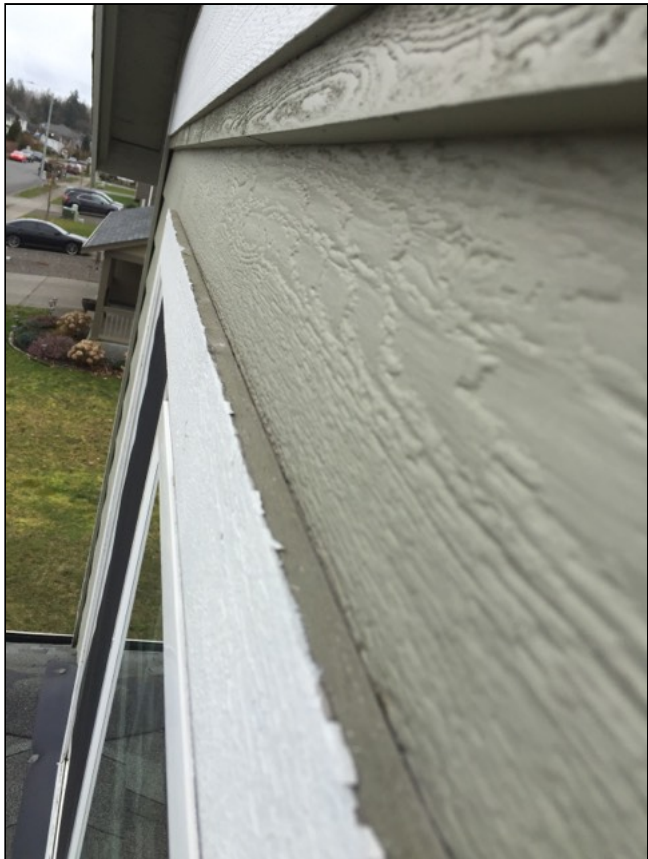
1.0 Item 5(Picture) Window trim caulking:

Item 5(Picture) Window trim caulking: Moisture can collect on these trim boards and ledges. Recommend maintenance caulking at all ledges, utility penetrations, and trim boards.

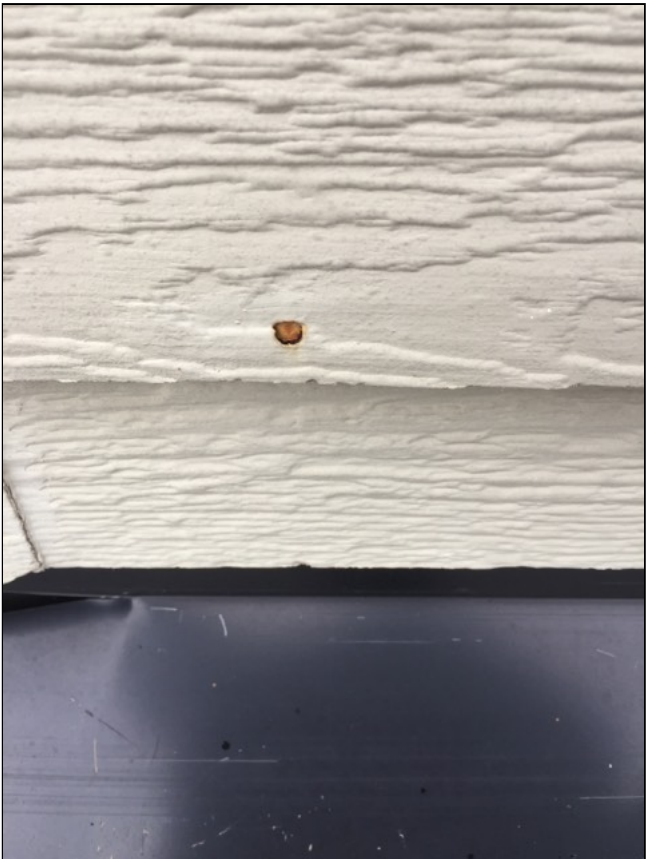
1.0 Item 6(Picture) Exposed nail heads

Item 6(Picture) Exposed nail heads: Nail heads were exposed. These areas are vulnerable to moisture wicking into the nail holes and rusting th nails and rotting the LP siding. rEcommend caulking and painting all exposed nail heads.

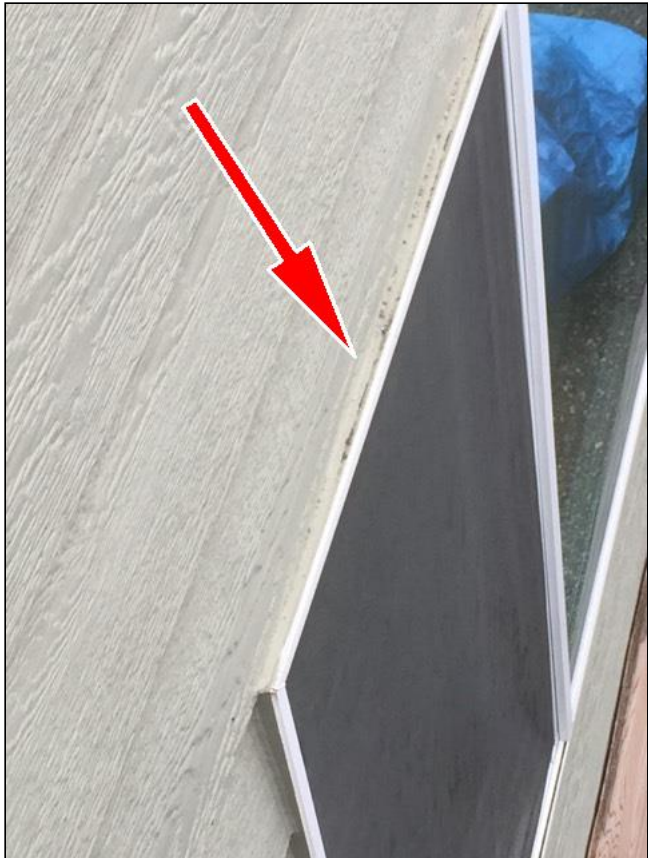
1.0 Item 7(Picture) No flashing

Item 7(Picture) No flashing: Some areas where exterior wall materials changed were not protected by flashing as required by good building practice. This condition may result in moisture intrusion of these areas.

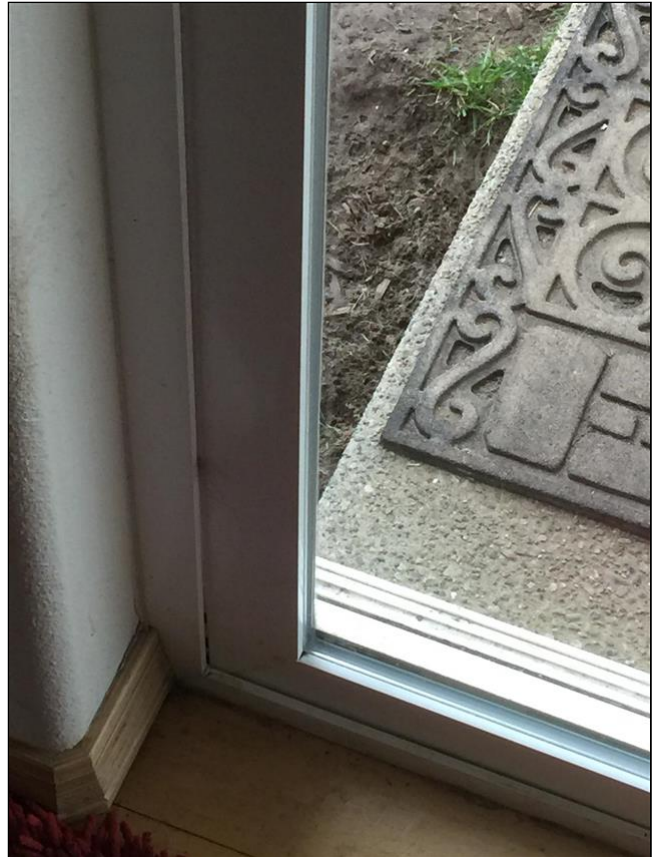
1.1 Item 2(Picture) Rear sliding door

Item 2(Picture) Rear sliding door: Rear sliding door did not close smoothly. Recommend repair by a licensed window contractor.

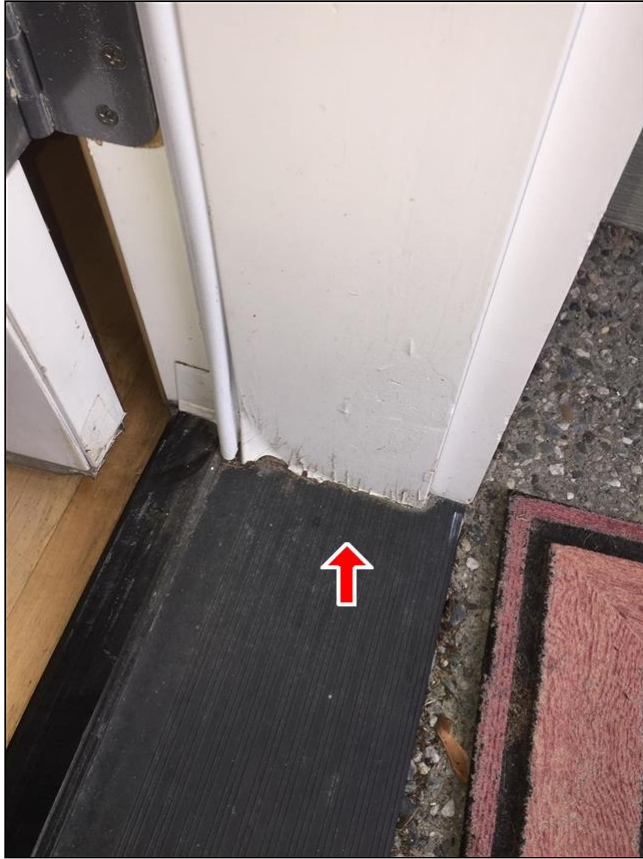
1.1 Item 3(Picture) trim paint

Item 3(Picture) trim paint: Recommend repainting all localized areas where paint was peeling.
